# PHASE IA & IB INVESTIGATION OF THE PROPOSED BHT ANDOVER DEVELOPMENT AT STICKLES POND ROAD

**PHASE IA & IB INVESTIGATION OF THE PROPOSED  
BHT DEVELOPMENT AT  
STICKLES POND ROAD  
SUSSEX COUNTY, NEW JERSEY**

**Technical Report No. 21-616**

**July 6, 2022**

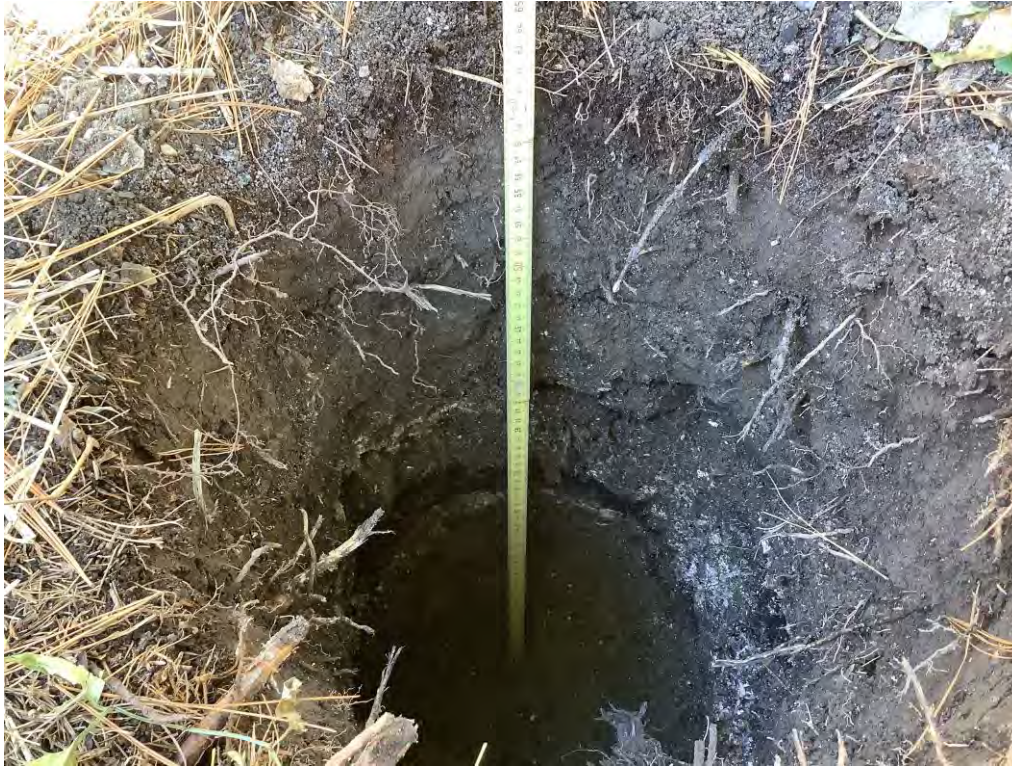
**Figure 33. STP 411 soil profile from Field Site A.**

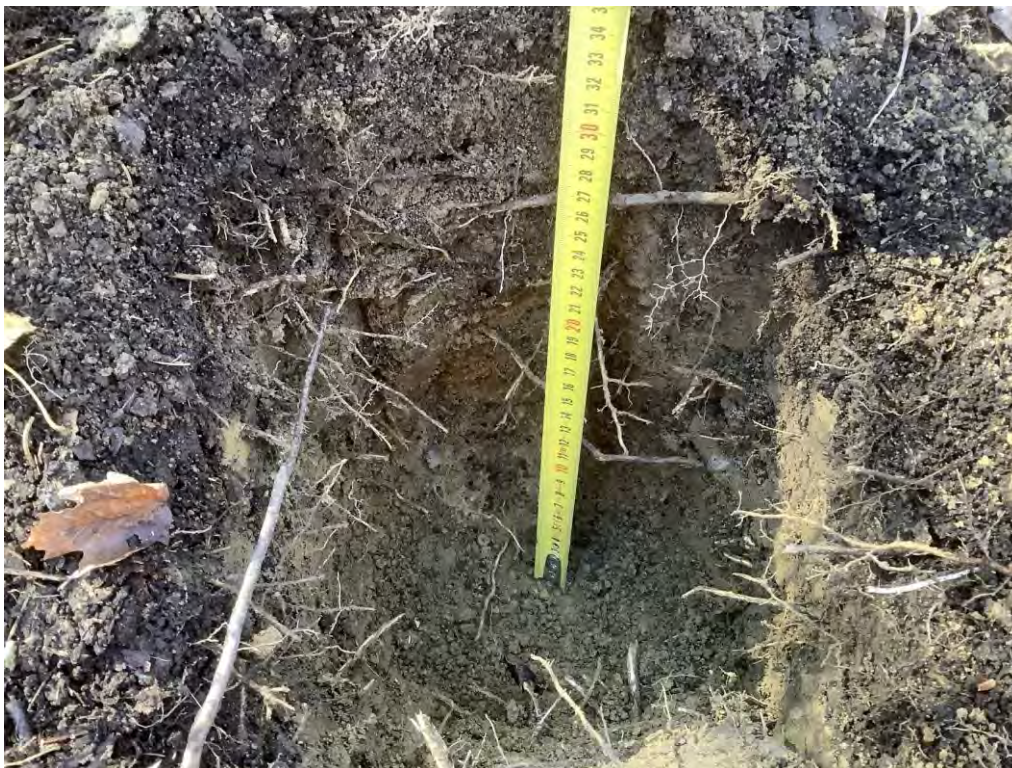
Figure 34. STP 425 soil profile from Field Site B.

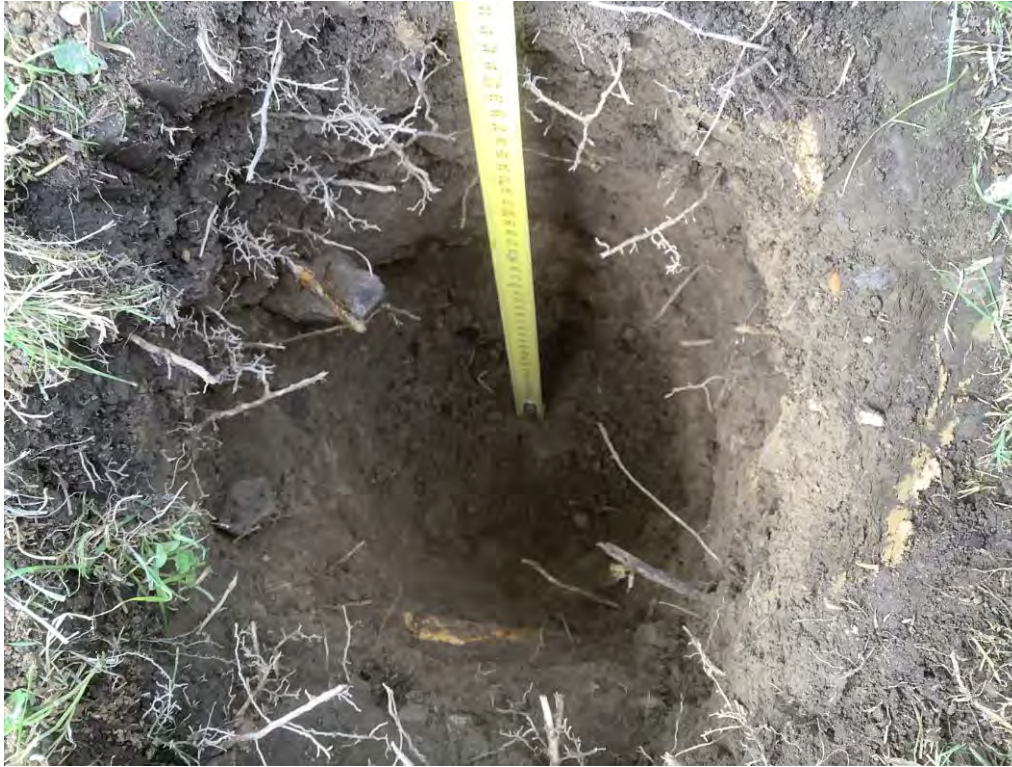
Figure 35. STP R04 soil profile from Field Site C.

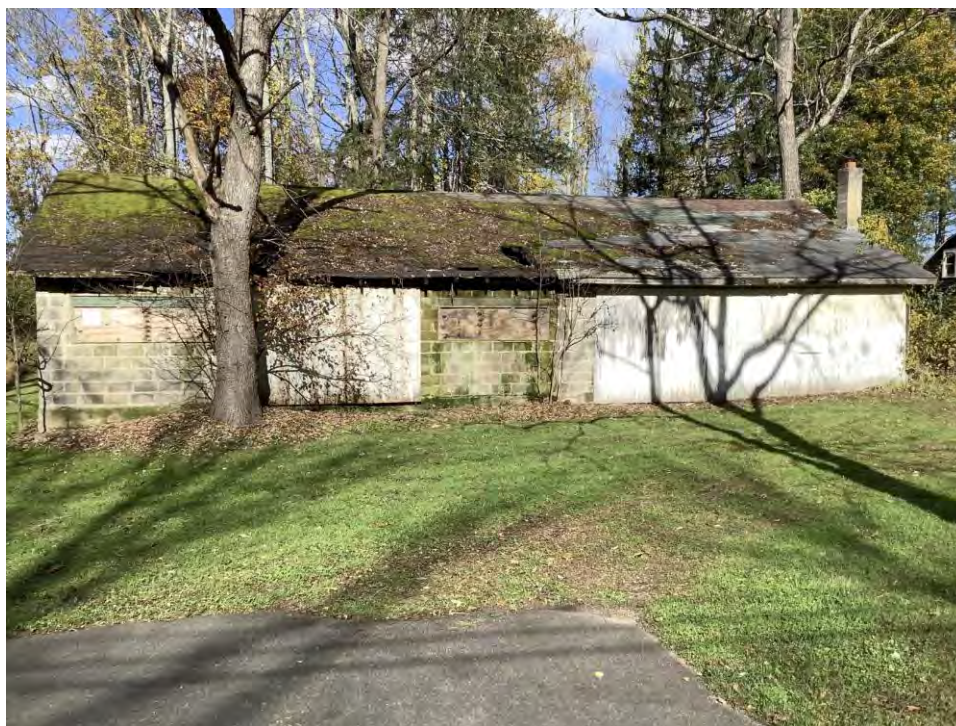
Figure 47. Photograph of 248 Stickles Road, Building #1, facing north.

**Eligibility Recommendation:** 248 Stickles Road, Building #1 is a one-story barn with Masonry Vernacular style, built circa 1920s with a rectangular-shaped plan. PaleoWest recommends that 248 Stickles Road, Building #1 is **not eligible for the NRHP**. 248 Stickles Road, Building #1 does not meet criteria A or B, as no significant historical associations were determined. It is not eligible under criterion C, as the building is not an exemplary or unique sample of its style. 248 Stickles Road, Building #1 is not eligible under criterion D, as it does not possess the potential to provide further information of historical importance

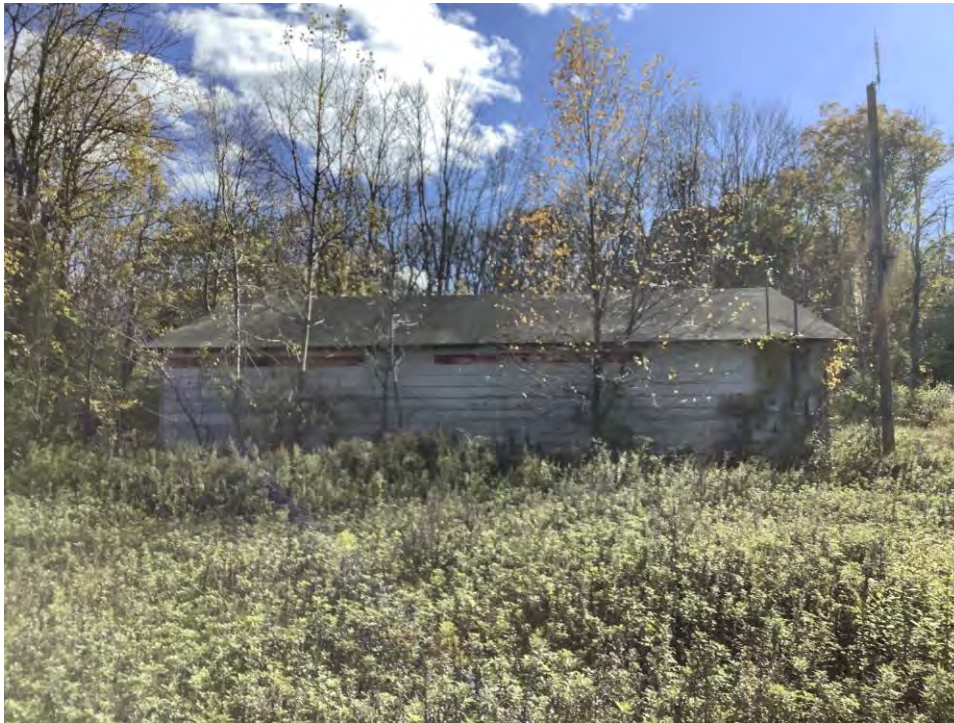
Figure 51. Photograph of 248 Stickles Pond Road, Building #2, facing south.

The building's main entryway is located on its front (west) elevation. This elevation has no wall below its front gable, creating a large entry bay. The right (south) and left (north) elevations have no fenestration. The rear (east) elevation also features no fenestration. A small poured concrete foundation partially fenced with a wooden privacy fence extends from the elevation. The structure's foundation is continuous concrete.

**Eligibility Recommendation:** 248 Stickles Road, Building 32 is a one-story garage with Frame Vernacular style, built circa 1970 with a rectangular-shaped plan. PaleoWest recommends that 248 Stickles Road, Building #2 is **not eligible for the NRHP**. 248 Stickles Road, Building #2 does not meet criteria A or B, as no significant historical associations were determined. It is not eligible under criterion C, as the building is not an exemplary or unique sample of its style. 248 Stickles Road, Building #2 is not eligible under criterion D, as it does not possess the potential to provide further information of historical importance.

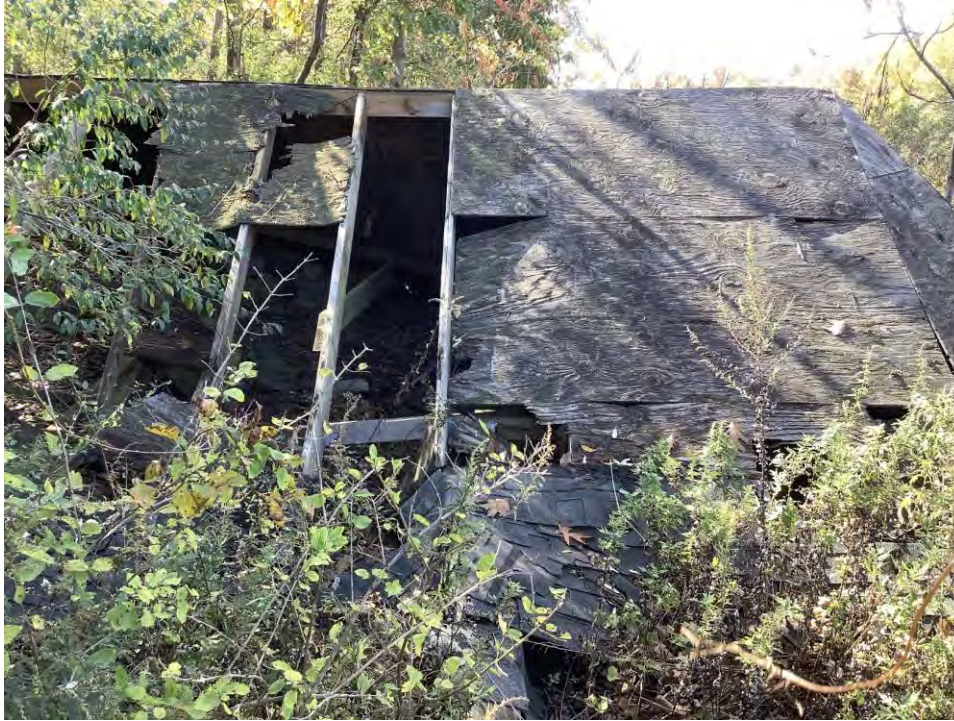
Figure 56. Photograph of 248 Stickles Pond Road, Building #3, - 1, facing west.

**Site Description:** 248 Stickles Pond Road, Building #3 is a ruinous building with no discernable style. The building, built circa 1970 (based on historical aerials), appears to have had a rectangular-shaped plan and an asphalt shingle gable roof when extant. The building was wood frame construction with no discernable cladding. No additional features are evident due to the building's condition.

**Eligibility Recommendation:** 248 Stickles Road, Building #3 is a one-story ruinous building with no style, built circa 1970 with a rectangular-shaped plan. PaleoWest recommends that 248 Stickles Road, Building #3 is **not eligible for the NRHP**. 248 Stickles Road, Building #3 does not meet criteria A or B, as no significant historical associations were determined. It is not eligible under criterion C, as the building is not an exemplary or unique sample of its style. 248 Stickles Road, Building #3 is not eligible under criterion D, as it does not possess the potential to provide further information of historical importance.

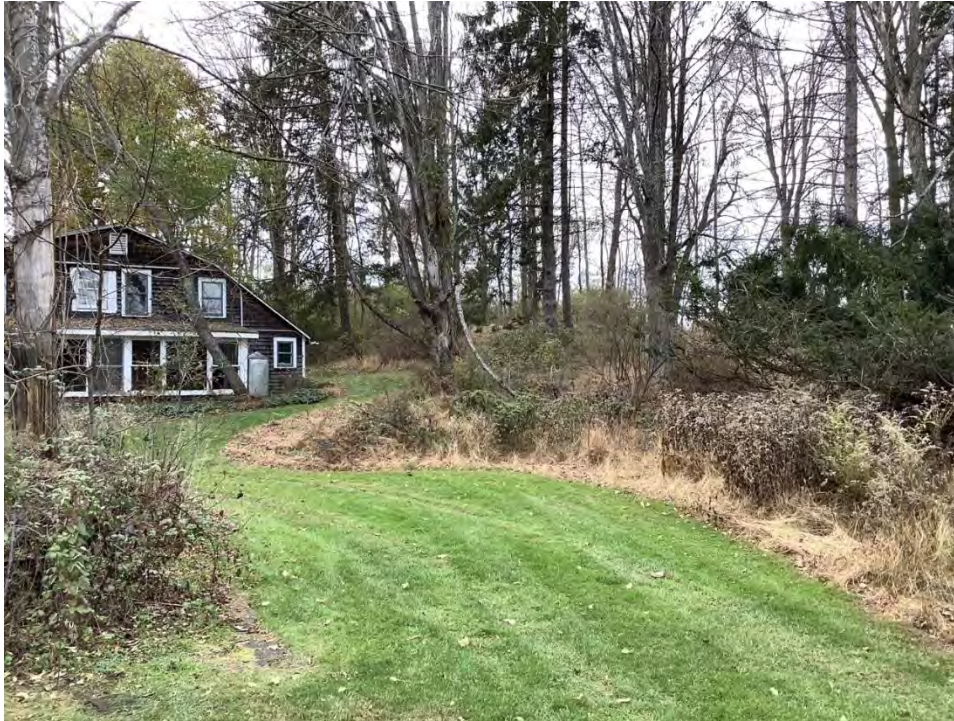
Figure 57. Photograph of 248 Stickles Road, Building #4, facing northwest.

**Eligibility Recommendation:** 248 Stickles Road, Building #4 is a two-story single-family residence (originally a barn) with Dutch Colonial Revival style, built circa 1890 with a rectangular-shaped plan. PaleoWest recommends that 248 Stickles Road, Building #4 is **not eligible for the NRHP**. 248 Stickles Road, Building #4 does not meet criteria A or B, as no significant historical associations were determined. It is not eligible under criterion C, as the building is not an exemplary or unique sample of its style and has been highly altered from its original appearance. 248 Stickles Road, Building #4 is not eligible under criterion D, as it does not possess the potential to provide further information of historical importance.

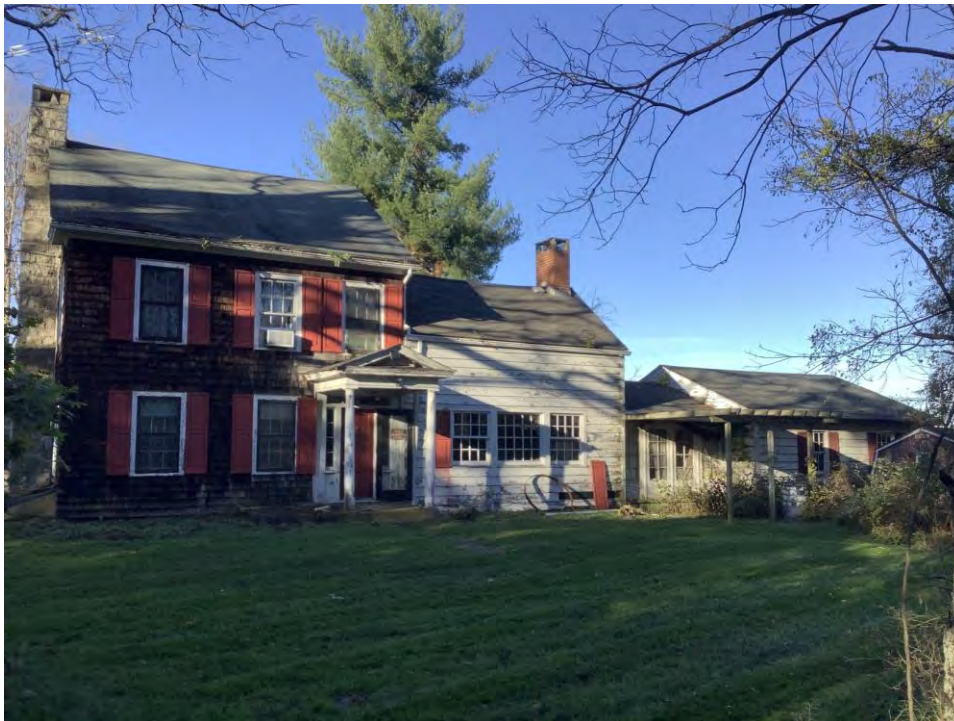
Figure 63. Photograph of 248 Stickles Pond Road, Building #5, facing northeast.

**Eligibility Recommendation:** 248 Stickles Road, Building #5 is a two-story single-family residence with Colonial style, built circa 1814-1823 with a rectangular-shaped plan. PaleoWest recommends that 248 Stickles Road, Building #5 is **not eligible for the NRHP**. 248 Stickles Road, Building #5 does not meet criteria A or B, as no significant historical associations were determined. It is not eligible under criterion C, as the building is not an exemplary or unique sample of its style. 248 Stickles Road, Building #5 is not eligible under criterion D, as it does not possess the potential to provide further information of historical importance

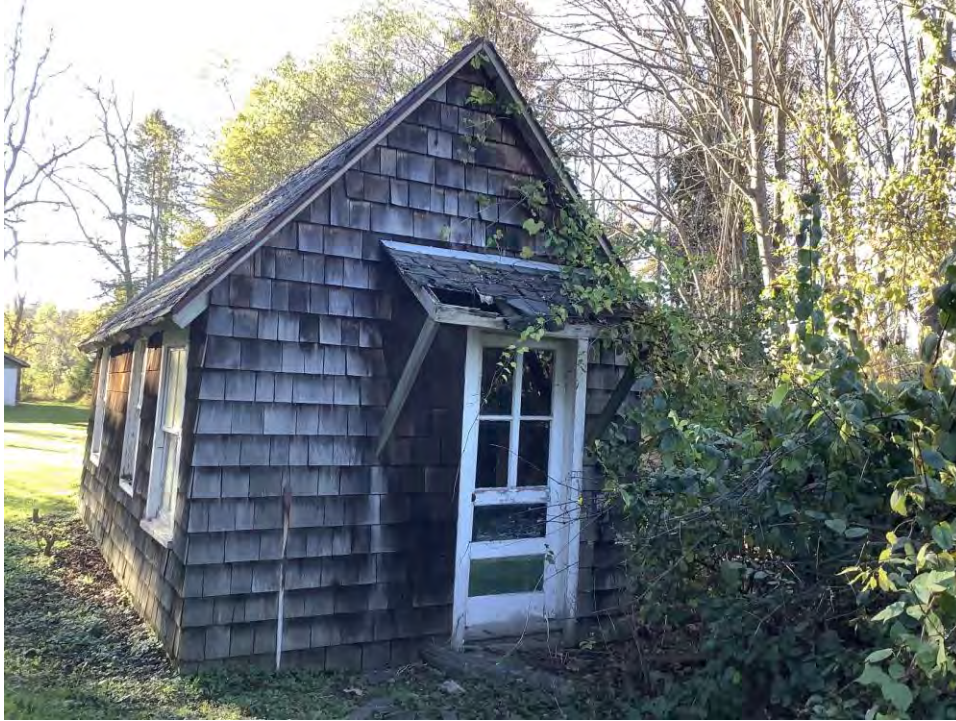
Figure 75. Photograph of 248 Stickles Road, Building 6, facing east.

**Eligibility Recommendation:** 248 Stickles Road, Building #6 is a one-story outbuilding with Colonial Revival style, built circa 1910 with a rectangular-shaped plan. PaleoWest recommends that 248 Stickles Road, Building #6 is **not eligible for the NRHP**. 248 Stickles Road, Building #6 does not meet criteria A or B, as no significant historical associations were determined. It is not eligible under criterion C, as the building is not an exemplary or unique sample of its style. 248 Stickles Road, Building #6 is not eligible under criterion D, as it does not possess the potential to provide further information of historical importance.

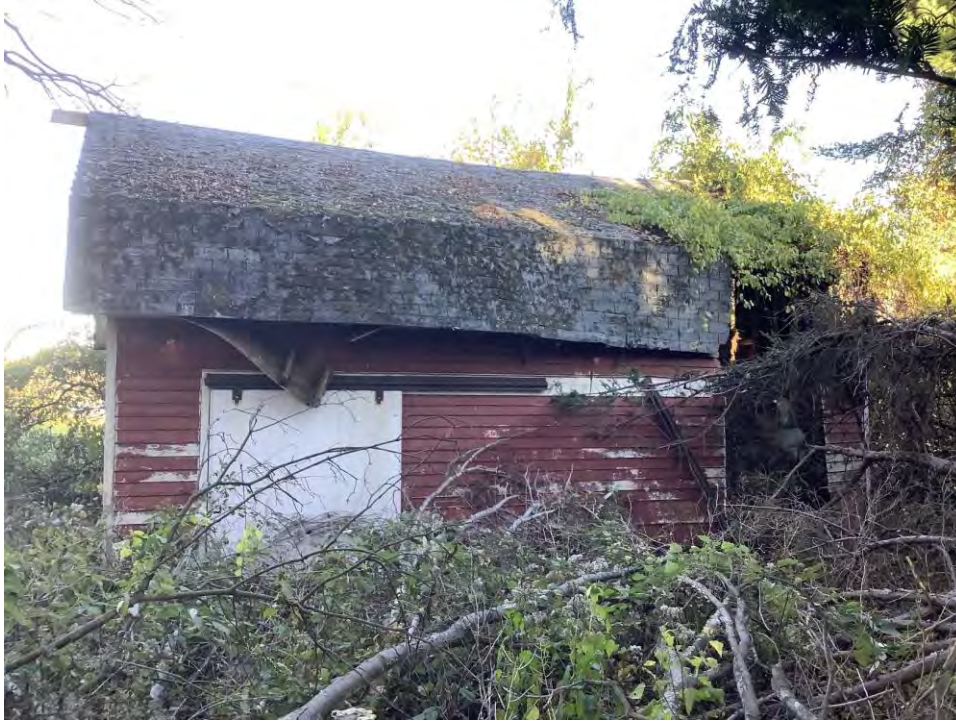
**Modifications:** Aluminum siding applied to building, replacement windows installed.

Figure 79. Photograph of 248 Stickles Road, Building 7, facing east.

**Eligibility Recommendation:** 248 Stickles Road, Building #7 is a two-story outbuilding (barn/storage) with Frame Vernacular style, built circa 1960 with a rectangular-shaped plan. PaleoWest recommends that 248 Stickles Road, Building #7 is **not eligible for the NRHP**. 248 Stickles Road, Building #7 does not meet criteria A or B, as no significant historical associations were determined. It is not eligible under criterion C, as the building is not an exemplary or unique sample of its style. 248 Stickles Road, Building #7 is not eligible under criterion D, as it does not possess the potential to provide further information of historical importance.

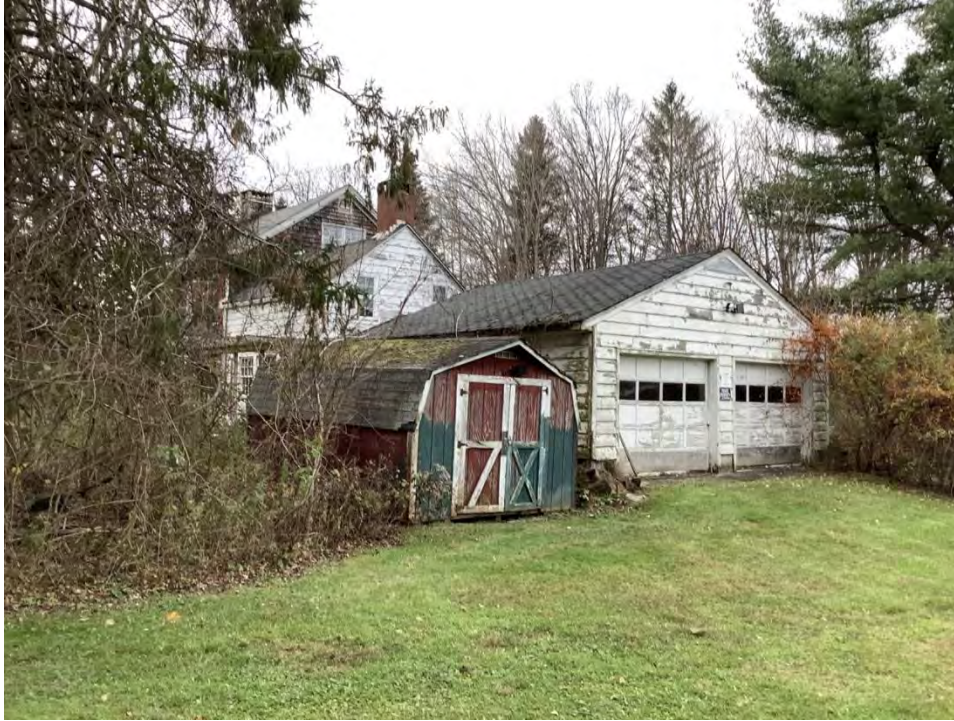
Figure 83. Photograph of Building #8 - Shed, facing west.

**Site Description:** 248 Stickles Pond Road, Building #8 (Shed) is a non-historic one-story outbuilding (shed) with no style located within the APE. The building, built circa 2000s (based off historical maps and the buildings style), has a rectangular-shaped plan and an asphalt shingled gambrel roof. This structure has a wood frame and is clad in vertical wood siding. The main entryway on this structure is located on the east elevation and consists of a pair of wooden entry doors. There are no window bays or doors anywhere on this building. This building has a foundation of concrete block piers.

**Eligibility Recommendation:** 248 Stickles Road, Building #8 (Shed) is a non-historic one-story outbuilding with no style, built circa 2000s with a rectangular-shaped plan. PaleoWest recommends that 248 Stickles Road, Building #8 is **not eligible for the NRHP**. 248 Stickles Road, Building #8 does not meet criteria A or B, as no significant historical associations were determined. It is not eligible under criterion C, as the building is not an exemplary or unique sample of its style. 248 Stickles Road, Building #8 is not eligible under criterion D, as it does not possess the potential to provide further information of historical importance.

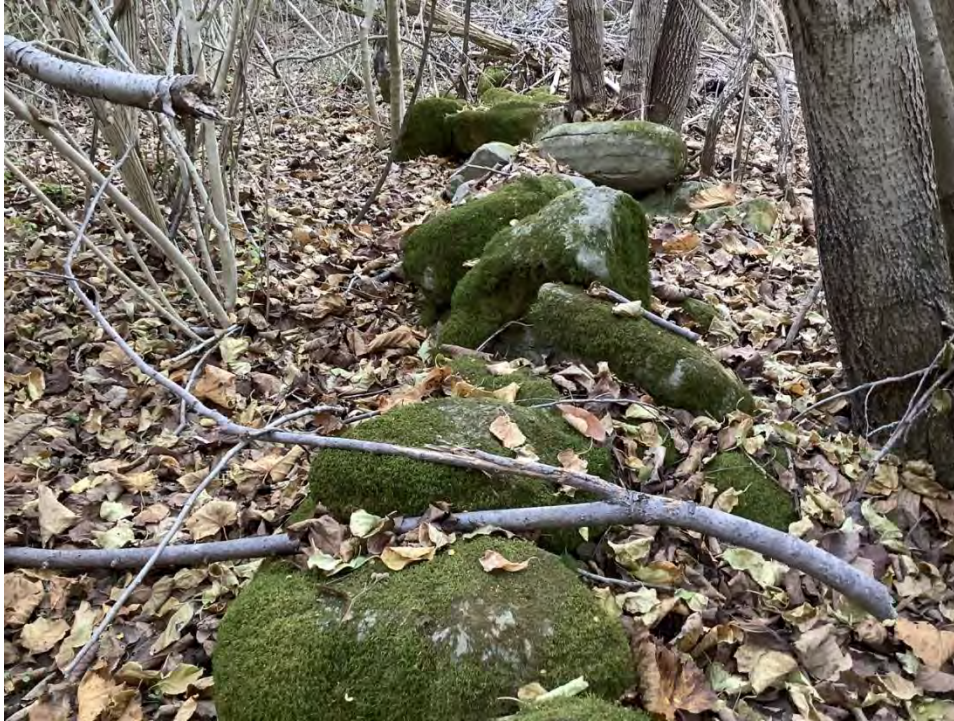
Figure 84. Photograph of Structure #1 – Stone Wall, facing southwest.

It should be noted that the remainder of this stone fence is no longer extant, only the portion documented here.

**Eligibility Recommendation:** 248 Stickles Road, Structure #1 is a portion of hand-stacked stone fence, built circa 1860. PaleoWest recommends that 248 Stickles Road, Structure 1 is **not eligible for the NRHP**. 248 Stickles Road, Structure #1 does not meet criteria A or B, as no significant historical associations were determined. It is not eligible under criterion C, as the building is not an exemplary or unique sample of its style. 248 Stickles Road, Structure #1 is not eligible under criterion D, as it does not possess the potential to provide further information of historical importance.

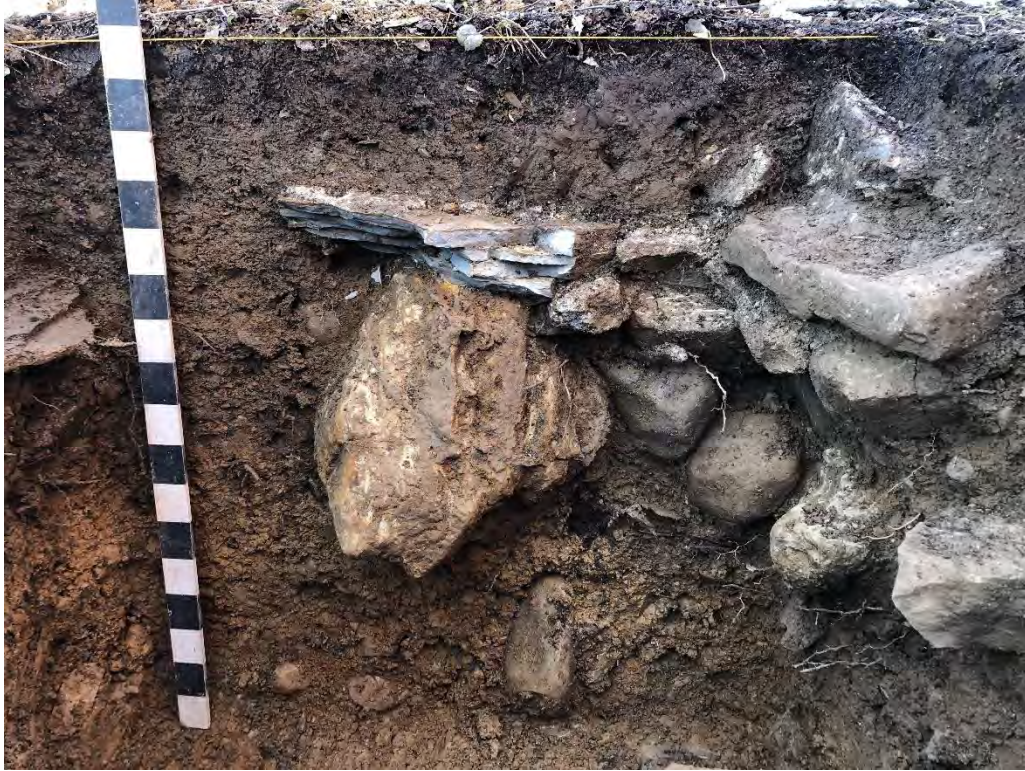
Figure 94. Detail of stones in TU1, western profile.

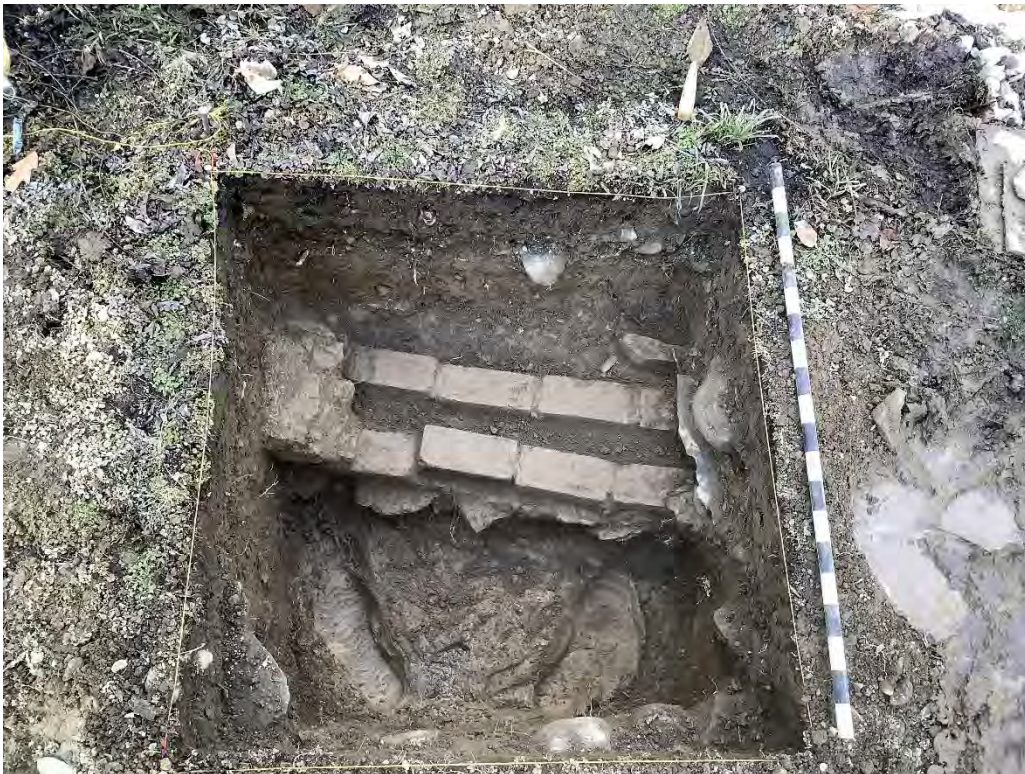
Field Site D consists of two positive 1x1 test units: TU1 and TU2. These units were placed to the south of Building 5 to inform on the structure's potential significance. The typical soil profile encountered in Field Site D consisted of a brown or dark yellowish brown (10YR 4/3, 4/4) silty clay loam (Stratum I), a dark yellowish brown or brown (10YR 4/6, 4/3) silty clay loam (Stratum II), a brown or dark grayish brown (10YR 4/3, 4/2) silty clay loam (Stratum III), and a yellowish brown or red yellowish brown (10YR 5/4, 5/6) clay (Stratum IV). Artifacts consisting of ferrous metal, ceramics, faunal bone, flat and vessel glass, brick, mortar, and coal were recovered from the first three strata. TU1 contained a dry stacked stone feature on the northwestern side of the unit and TU2 has a linear stone and brick feature in the northern half of the unit, running parallel to the house. These features are suspected to be drains associated with the building.

Figure 95. Potential drain feature in TU2.
