STORMWATER MANAGEMENT MAINTENANCE MANUAL

248 Stickles Pond Road Block 151 Lot 21 Andover Township Sussex County, New Jersey

Prepared For: BHT Properties Group 5081 SW 48th Street, 1023 Davie, Florida 33314

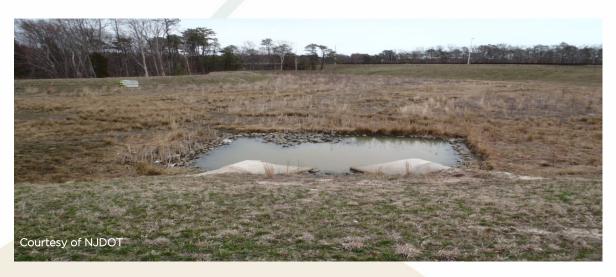
Issue: The inlet is not properly drained, assuming it has not rained within

72 hours.

Preventative Action: Routine inspections and removal of sediment from the forebay.

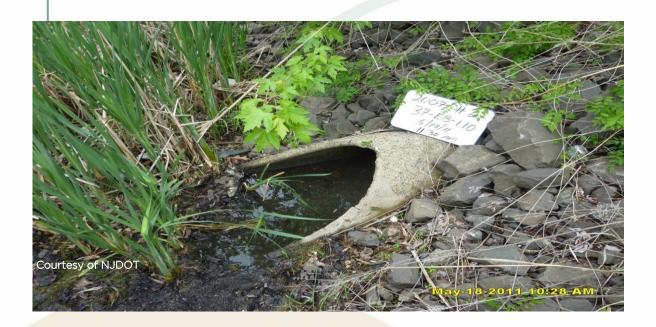
Issue: The Inflow pipe is clogged by sediment and vegetation.

Corrective Action: Clear and remove sediment and unwanted vegetation.

Preventative Action: Routine inspection and removal of sediment and unwanted vegetation.

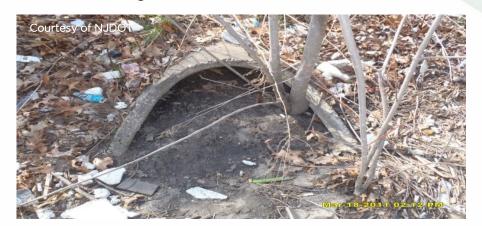
Issue: The Inflow pipe is entirely clogged by sediment and trees.

Corrective Action: Clear and remove sediment and trees.

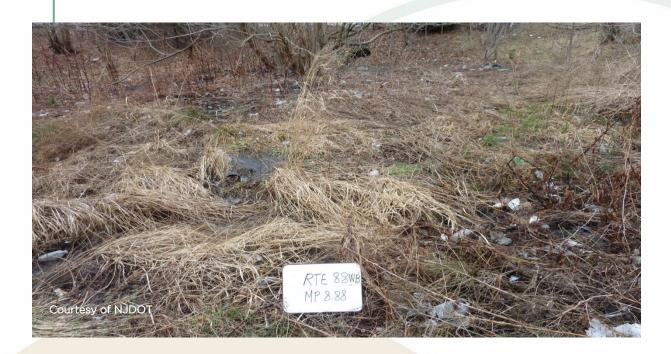
The excessive sediment in inflow pipe (shown above) might be caused by a blockage of flow to the basin due to excessive vegetation and overgrown trees. Issue:

Clear and remove trees and vegetation. If necessary, re-grade the bottom slope to ensure the flow properly spreads over the basin Corrective Action:

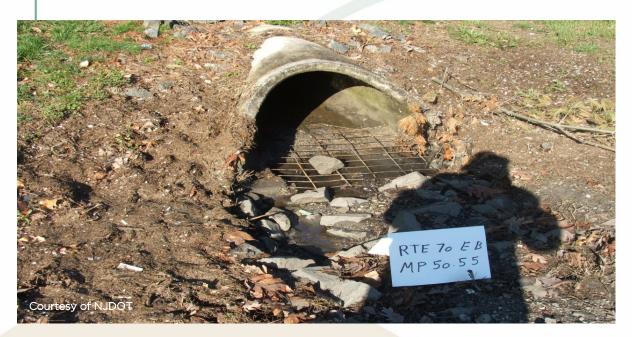
Issue: Eroded inflow apron.

Corrective Action: Repair apron.

Preventative Action: Routine inspection and rehabilitation, if necessary.

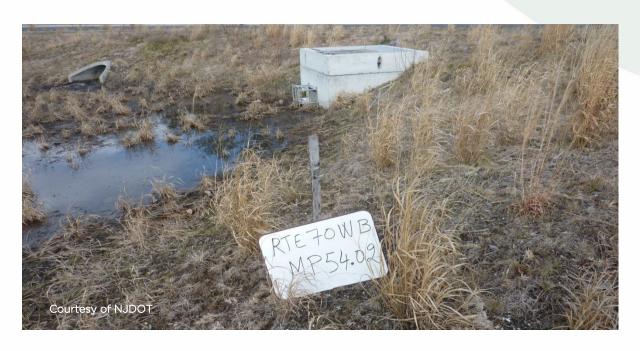
The vegetation loss and the blackish soil may indicate frequent

Replace the soil if necessary.

Preventative Action: Routine inspection and tilling/aeration, if necessary.

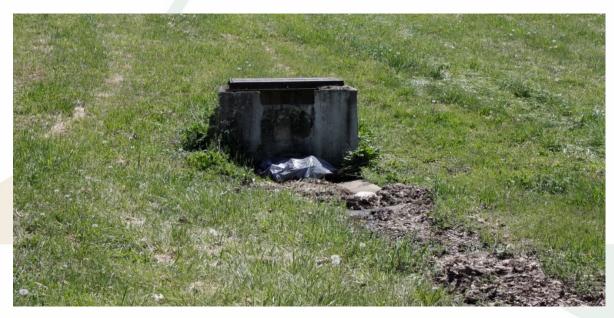
Issue: The low flow channel has excessive accumulation of sediment and

debris. The outflow orifice is clogged by a trash bag and debris.

Preventative Action: Routine inspection and cleaning.

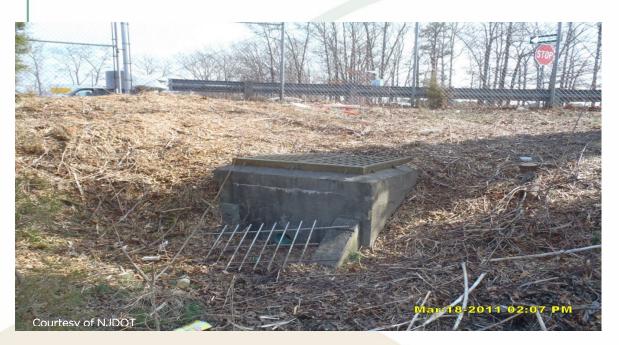
Trash rack is damaged. Issue:

Corrective Action: Repair the trash rack.

Routine inspection, especially after large storm events. Tighten any loose bolts and repair structural flaws. Preventative Action:

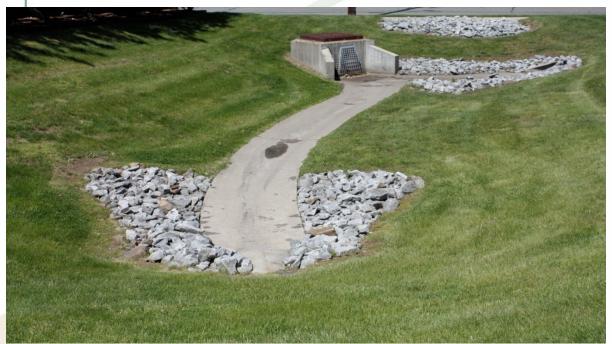
A well-maintained detention basin

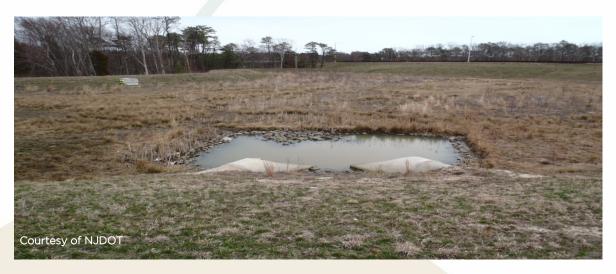
Issue: The inlet is not properly drained, assuming it has not rained within

72 hours.

Preventative Action: Routine inspections and removal of sediment from the forebay.

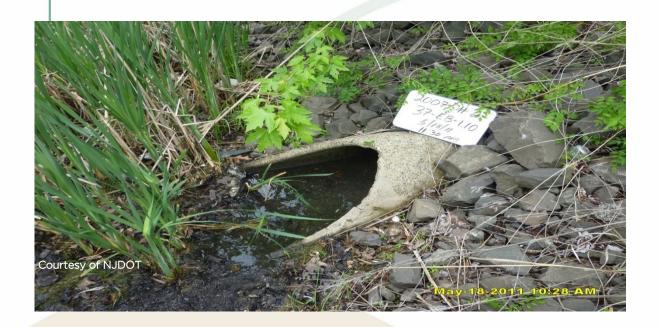
Issue: The Inflow pipe is clogged by sediment and vegetation.

Corrective Action: Clear and remove sediment and unwanted vegetation.

Preventative Action: Routine inspection and removal of sediment and unwanted vegetation.

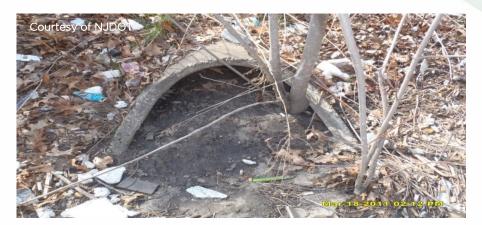
Issue: The Inflow pipe is entirely clogged by sediment and trees.

Corrective Action: Clear and remove sediment and trees.

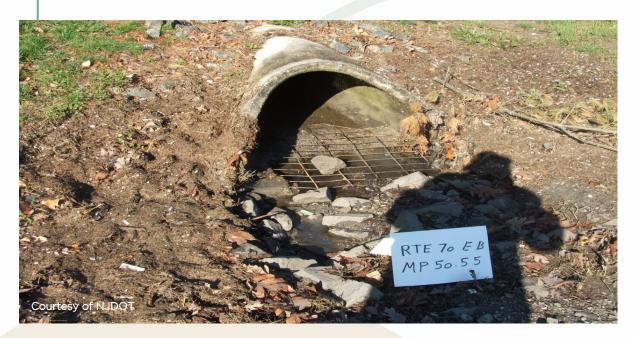
Issue: Eroded inflow apron.

Corrective Action: Repair apron.

Preventative Action: Routine inspection and rehabilitation, if necessary.

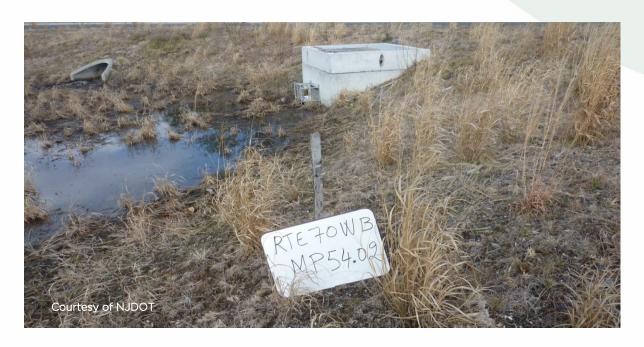
The vegetation loss and the blackish soil may indicate frequent

Replace the soil if necessary.

Preventative Action: Routine inspection and tilling/aeration, if necessary.

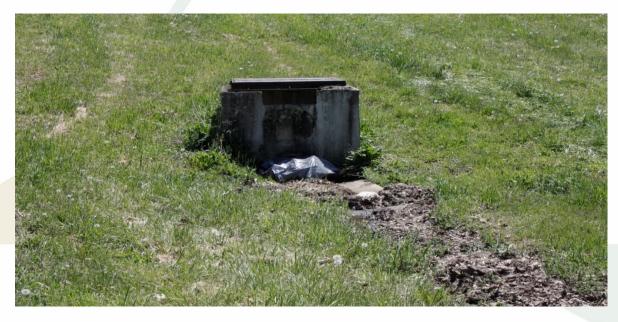
Issue: The low flow channel has excessive accumulation of sediment and

debris. The outflow orifice is clogged by a trash bag and debris.

Preventative Action: Routine inspection and cleaning.

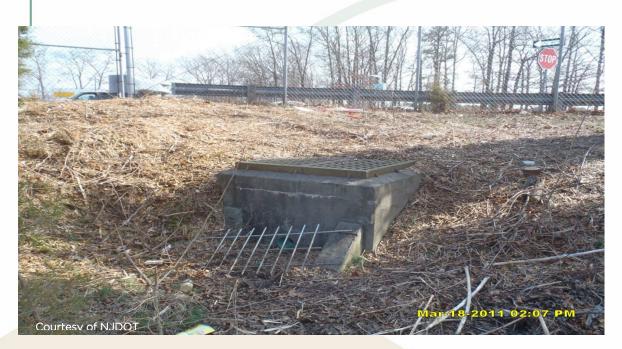
Trash rack is damaged. Issue:

Corrective Action: Repair the trash rack.

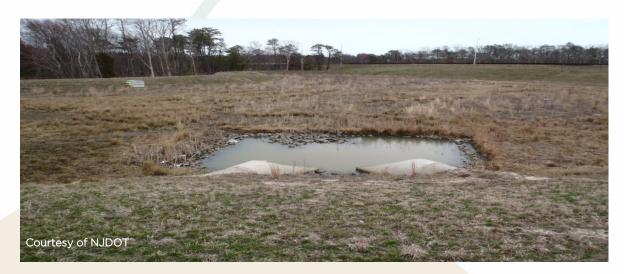
Issue: The inlet is not properly drained, assuming it has not rained within

72 hours.

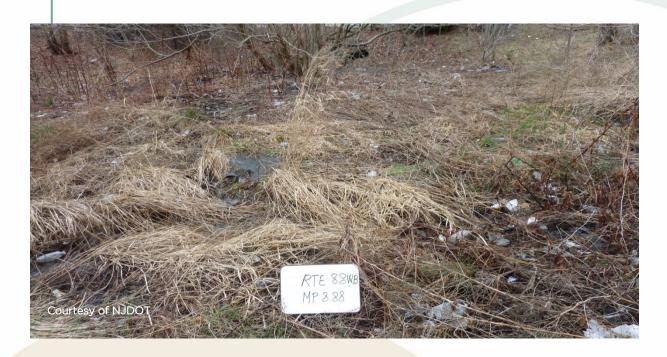
The excessive sediment in inflow pipe (shown above) might be caused by a blockage of flow to the basin due to excessive vegetation and overgrown trees. Issue:

Clear and remove trees and vegetation. If necessary, re-grade the bottom slope to ensure the flow properly spreads over the basin Corrective Action:

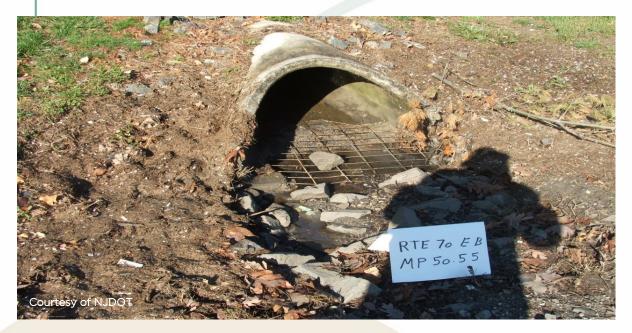
Issue: Eroded inflow apron.

Corrective Action: Repair apron.

Preventative Action: Routine inspection and rehabilitation, if necessary.

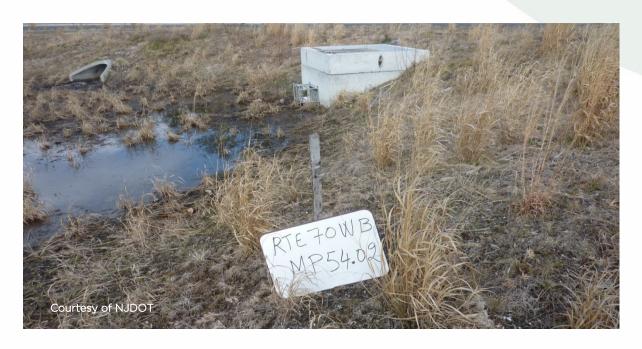
The vegetation loss and the blackish soil may indicate frequent

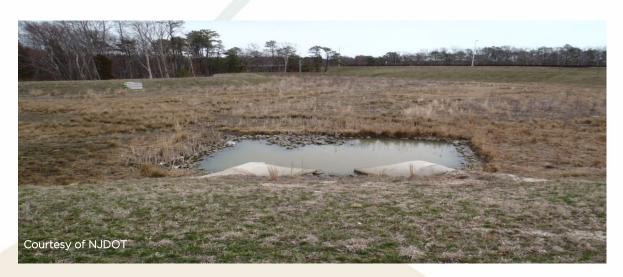
Issue: The inlet is not properly drained, assuming it has not rained within

72 hours.

Preventative Action: Routine inspections and removal of sediment from the forebay.

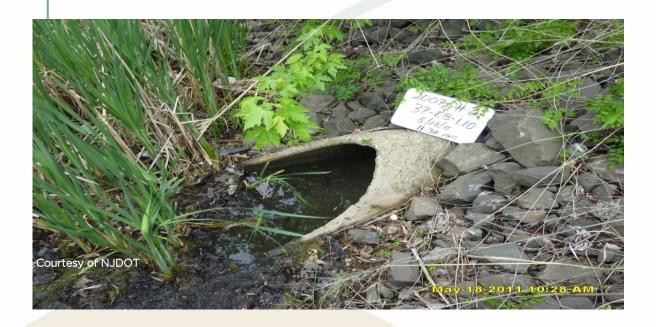
Issue: The Inflow pipe is clogged by sediment and vegetation.

Corrective Action: Clear and remove sediment and unwanted vegetation.

Preventative Action: Routine inspection and removal of sediment and unwanted vegetation.

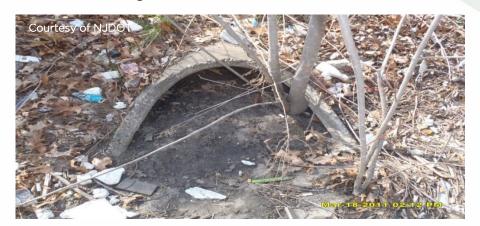
Issue: The Inflow pipe is entirely clogged by sediment and trees.

Corrective Action: Clear and remove sediment and trees.

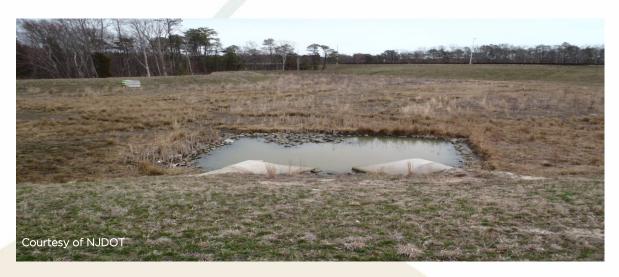
Issue: The inlet is not properly drained, assuming it has not rained within

72 hours.

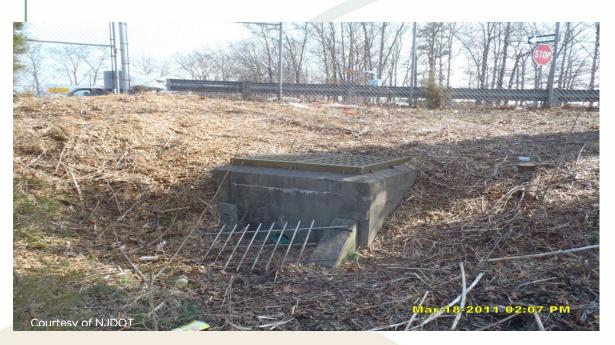
Trash rack is damaged. Issue:

Corrective Action: Repair the trash rack.

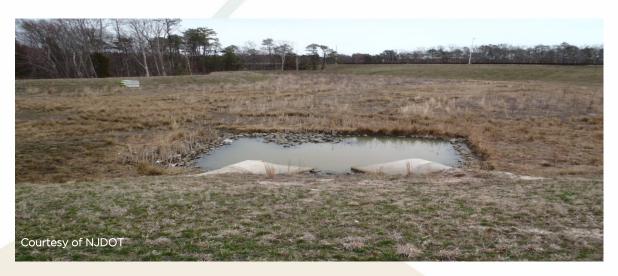
Issue: The inlet is not properly drained, assuming it has not rained within

72 hours.

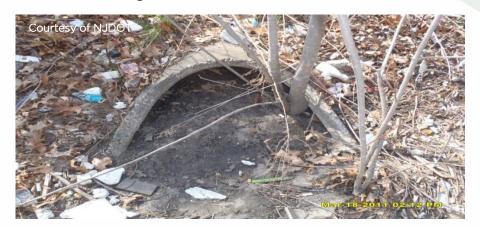
Issue: The Inflow pipe is entirely clogged by sediment and trees.

Corrective Action: Clear and remove sediment and trees.
