STORMWATER
MANAGEMENT
MAINTENANCE
MANUAL

248 Stickles Pond Road
Block 151 Lot 21
Andover Township
Sussex County, New
Jersey

Prepared For:
BHT Properties Group
5081 SW 48th Street, 1023
Davie, Florida 33314

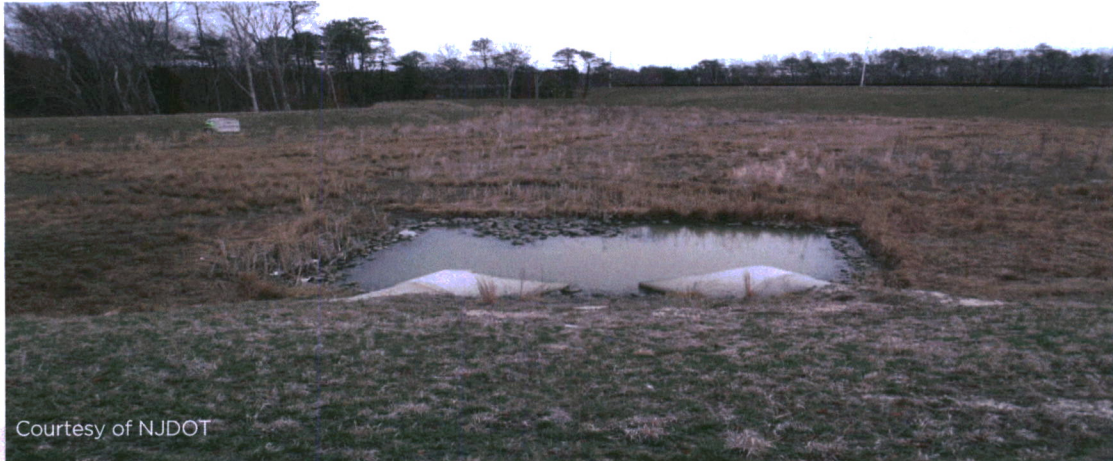
Issue:	The inlet is not properly drained, assuming it has not rained within 72 hours.
Corrective Action:	Clear and remove sediment. Check whether the water table is at or above the bottom of the forebay. Also check the permeability of the underlying soil, if necessary.
Preventative Action:	Routine inspections and removal of sediment from the forebay.

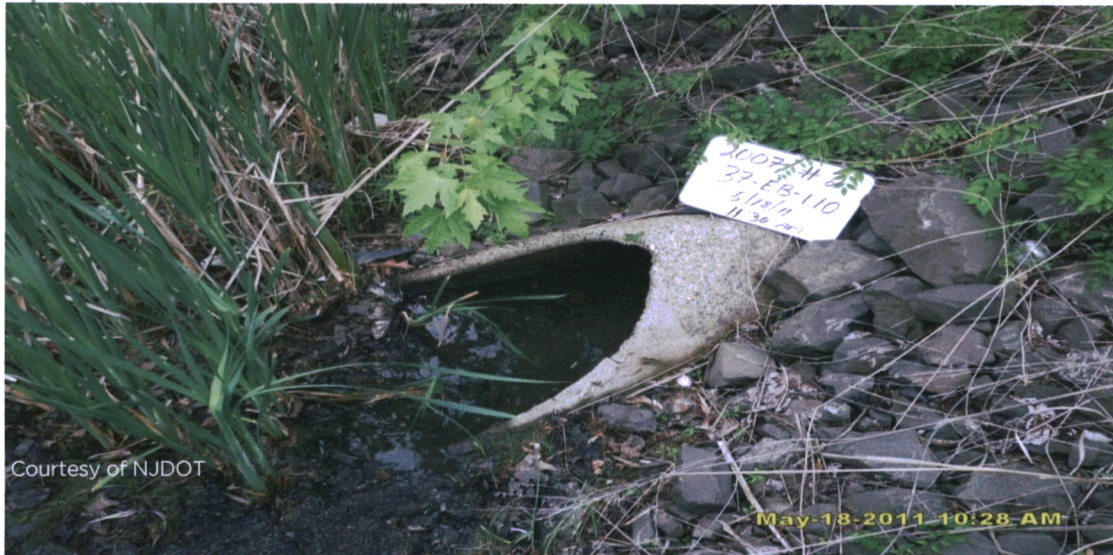
Issue: The Inflow pipe is clogged by sediment and vegetation.

Corrective Action: Clear and remove sediment and unwanted vegetation.

Preventative Action: Routine inspection and removal of sediment and unwanted vegetation.

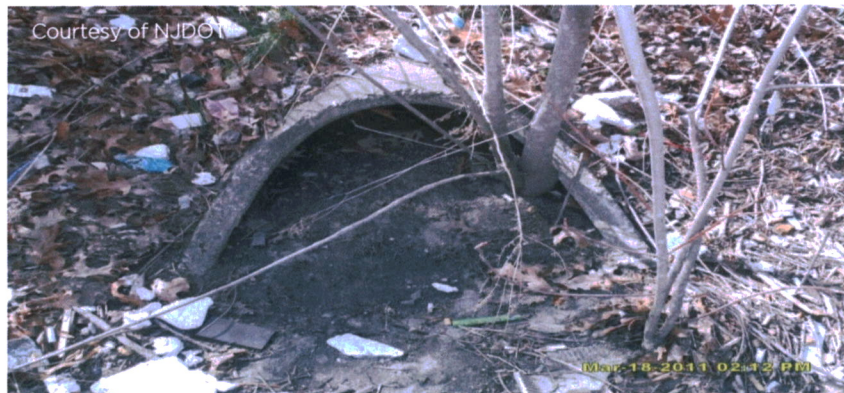
Issue: The Inflow pipe is entirely clogged by sediment and trees.

Corrective Action: Clear and remove sediment and trees.

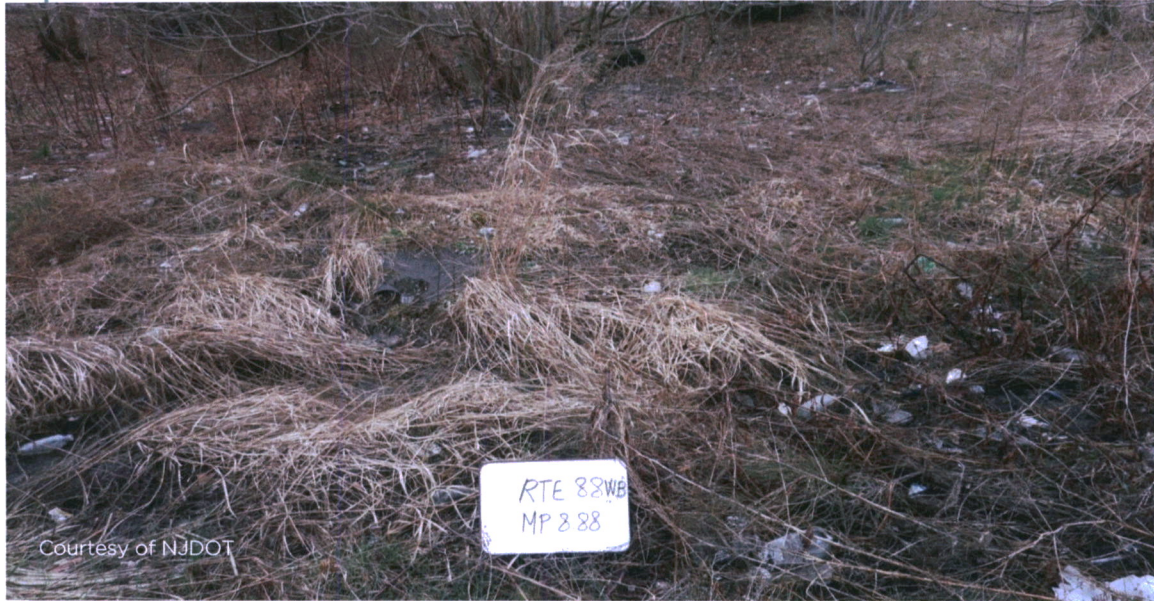
Issue:

The excessive sediment in inflow pipe (shown above) might be caused by a blockage of flow to the basin due to excessive vegetation and overgrown trees.

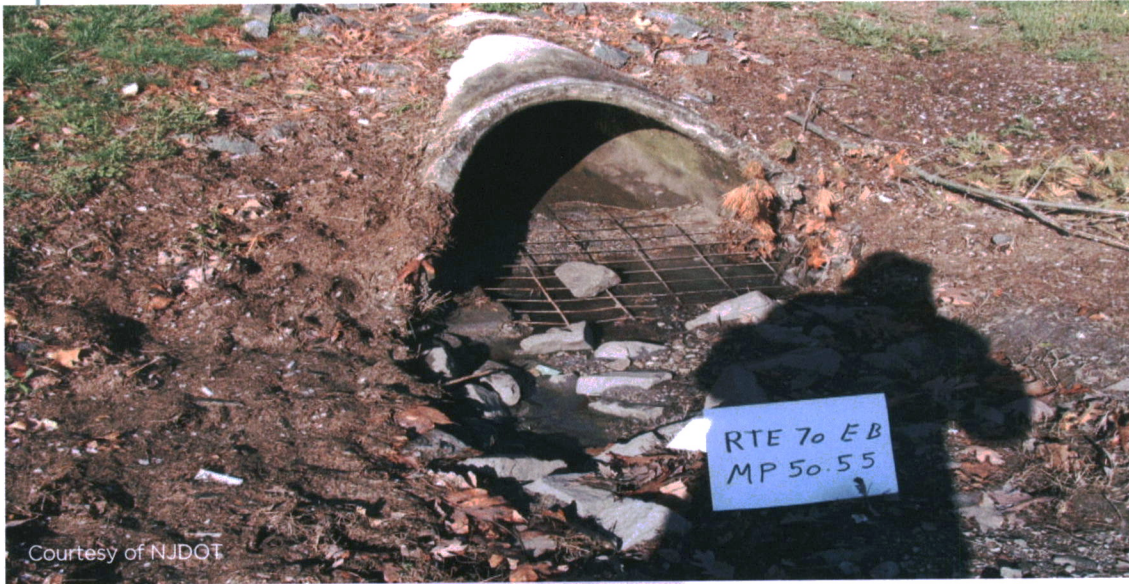
Issue: Eroded inflow apron.
Corrective Action: Repair apron.
Preventative Action: Routine inspection and rehabilitation, if necessary.

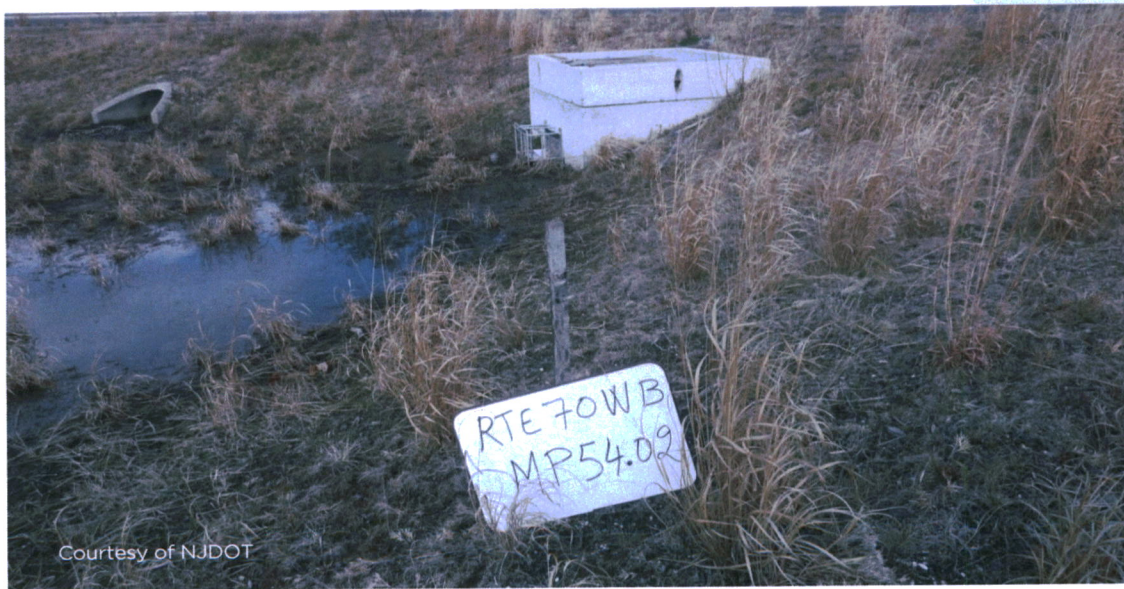
Issue:

The vegetation loss and the blackish soil may indicate frequent inundation.

Check the permeability rate of the soil and the water table elevation. Replace the soil if necessary.

Routine inspection and tilling/aeration, if necessary.

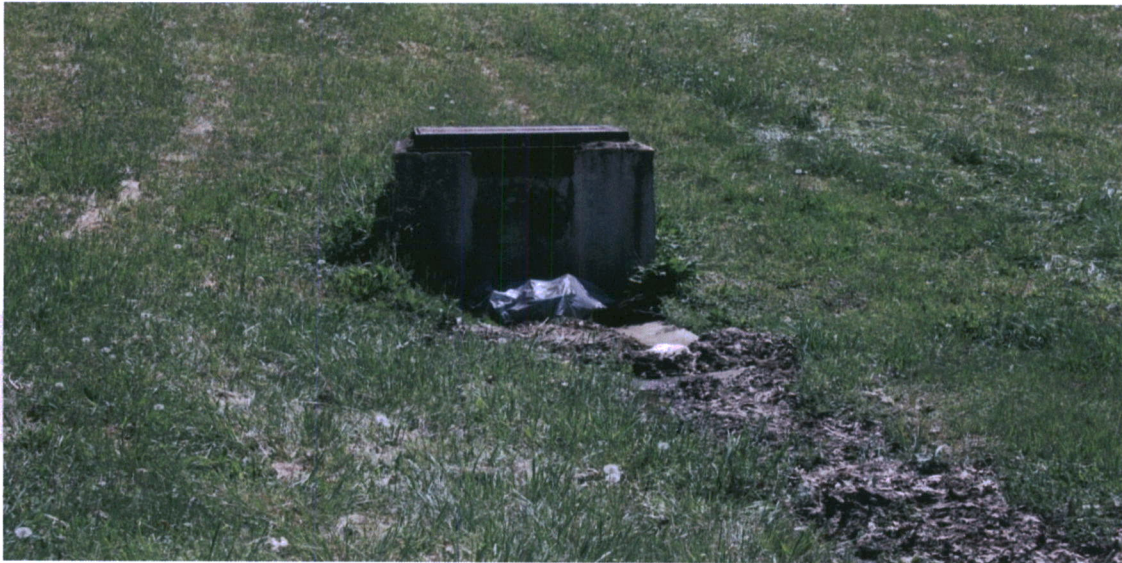
Issue:

The low flow channel has excessive accumulation of sediment and debris. The outflow orifice is clogged by a trash bag and debris. Note that there is no trash rack installed.

Check the permeability rate of the soil and the water table elevation. Replace the soil if necessary.

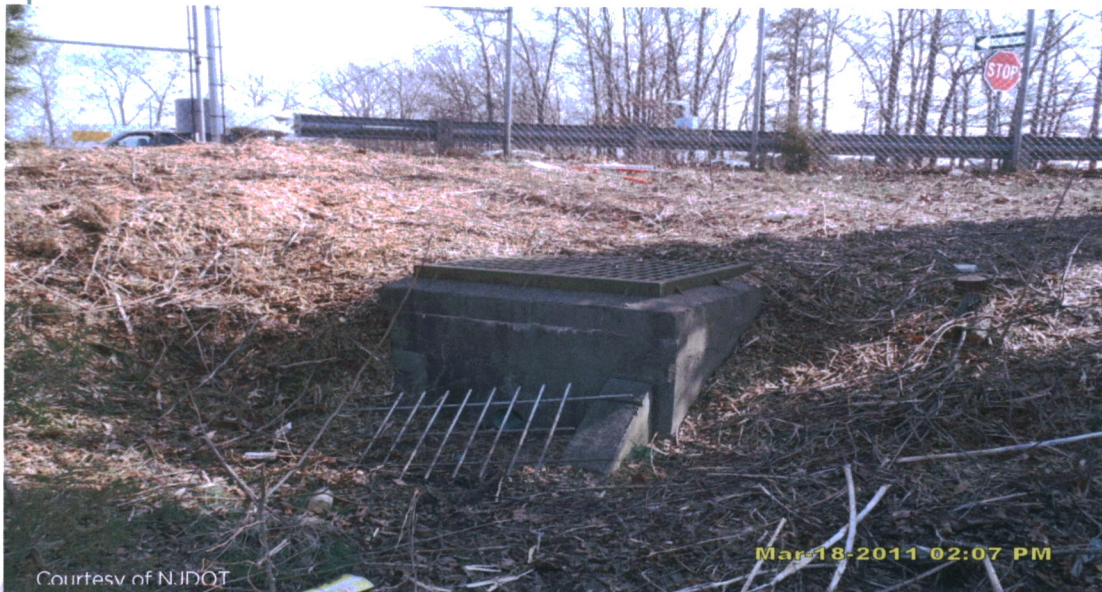
Issue:	Trash rack is damaged.
Corrective Action:	Repair the trash rack.
Preventative Action:	Routine inspection, especially after large storm events. Tighten any loose bolts and repair structural flaws.

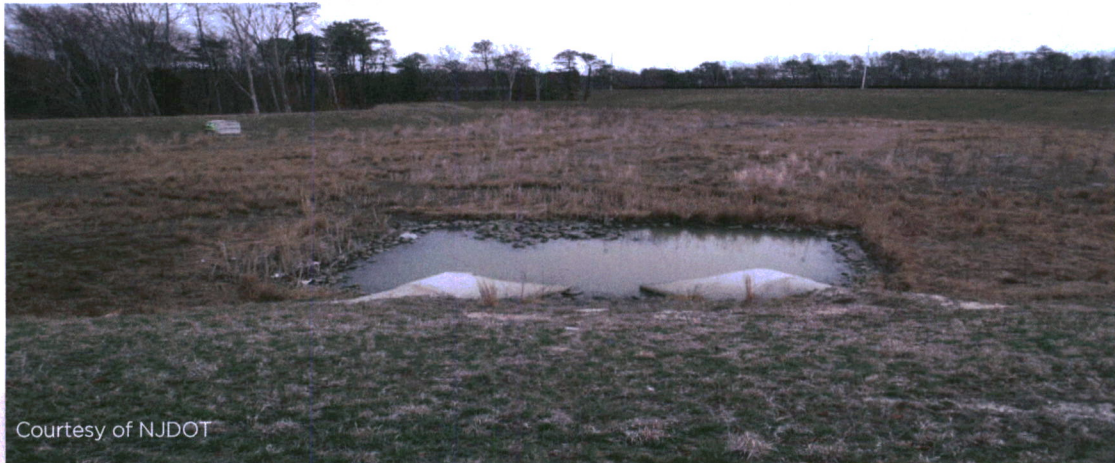
Issue:	The inlet is not properly drained, assuming it has not rained within 72 hours.
Corrective Action:	Clear and remove sediment. Check whether the water table is at or above the bottom of the forebay. Also check the permeability of the underlying soil, if necessary.
Preventative Action:	Routine inspections and removal of sediment from the forebay.

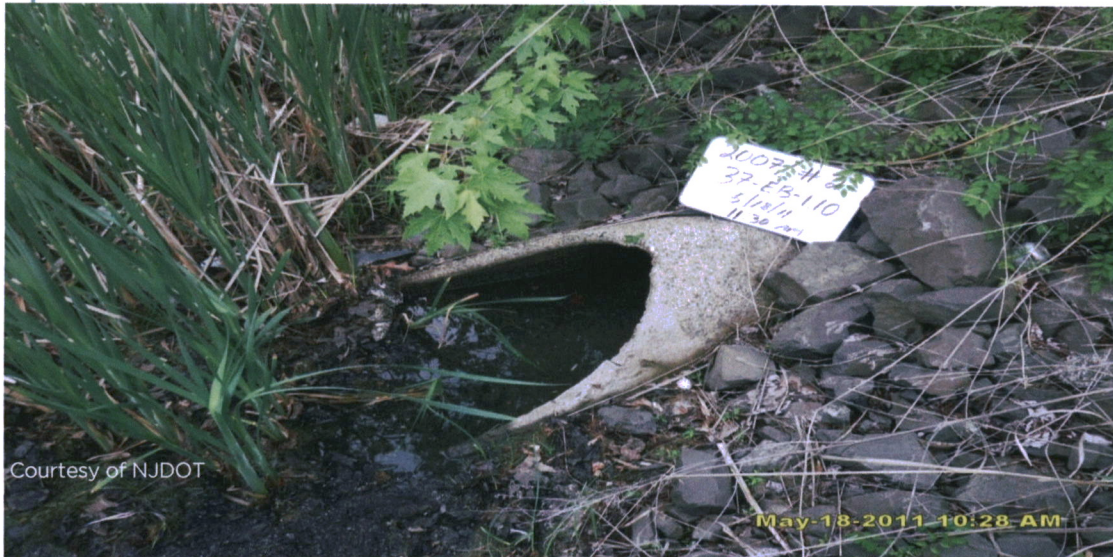
Issue: The Inflow pipe is clogged by sediment and vegetation.
 Corrective Action: Clear and remove sediment and unwanted vegetation.
 Preventative Action: Routine inspection and removal of sediment and unwanted vegetation.

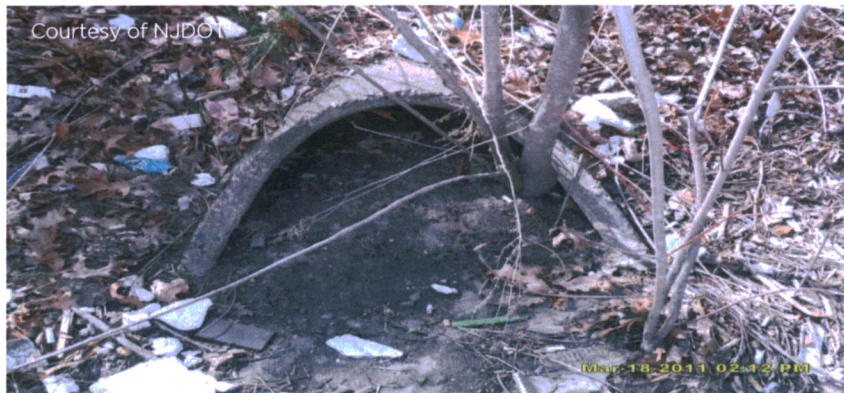
Issue: The Inflow pipe is entirely clogged by sediment and trees.
 Corrective Action: Clear and remove sediment and trees.
 Preventative Action: Routine inspection & removal of sediment and unwanted vegetation.

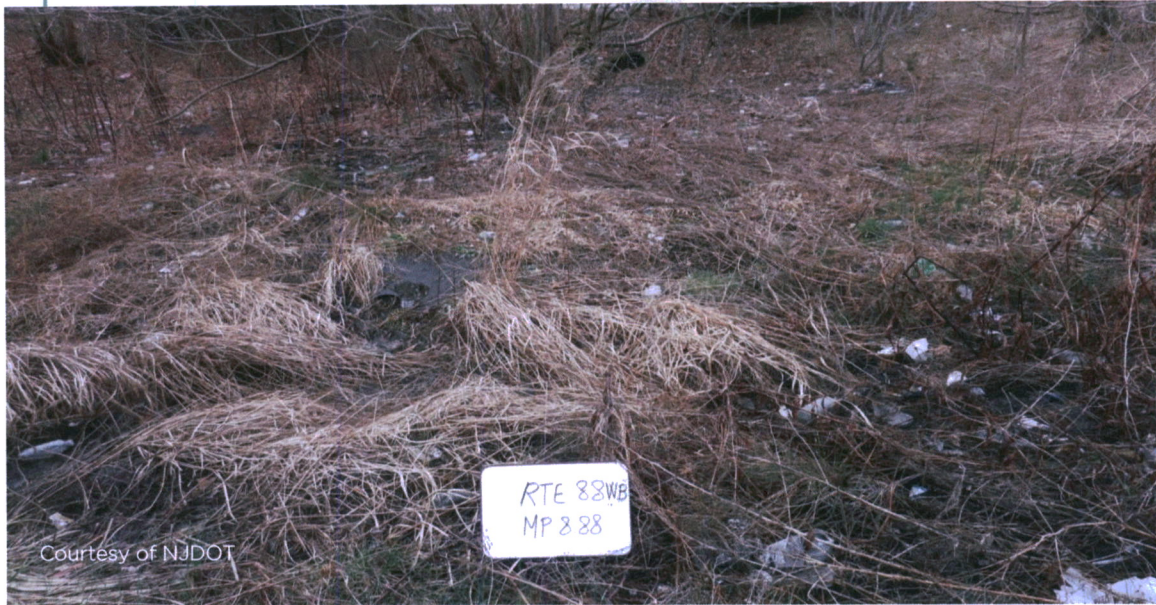
- Issue: The excessive sediment in inflow pipe (shown above) might be caused by a blockage of flow to the basin due to excessive vegetation and overgrown trees.
- Corrective Action: Clear and remove trees and vegetation. If necessary, re-grade the bottom slope to ensure the flow properly spreads over the basin bottom.
- Preventative Action: Routine inspection and removal of sediment and unwanted vegetation.

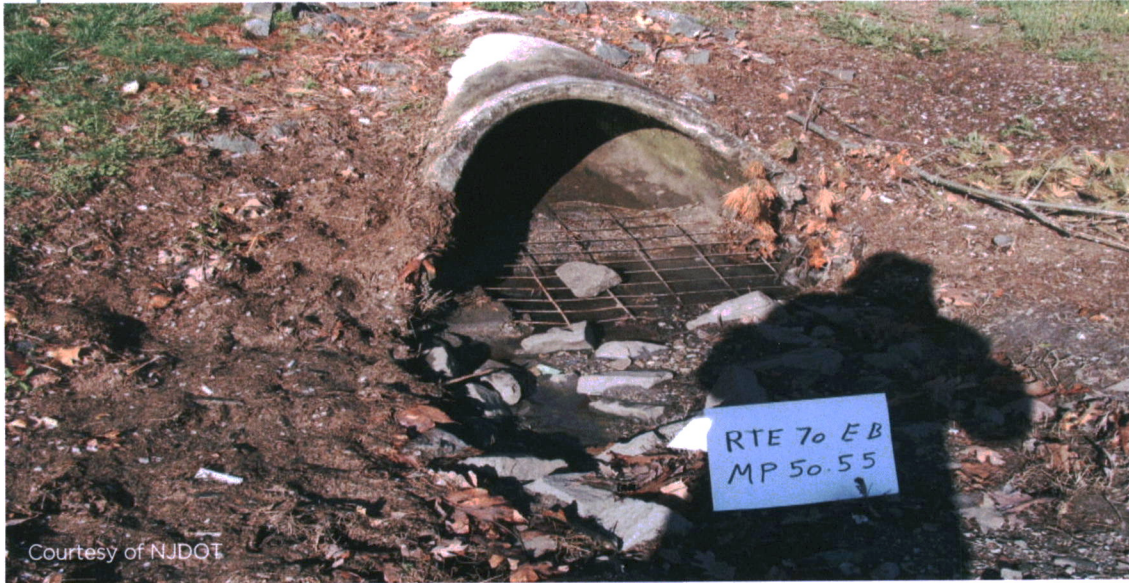
Issue: Eroded inflow apron.
Corrective Action: Repair apron.
Preventative Action: Routine inspection and rehabilitation, if necessary.

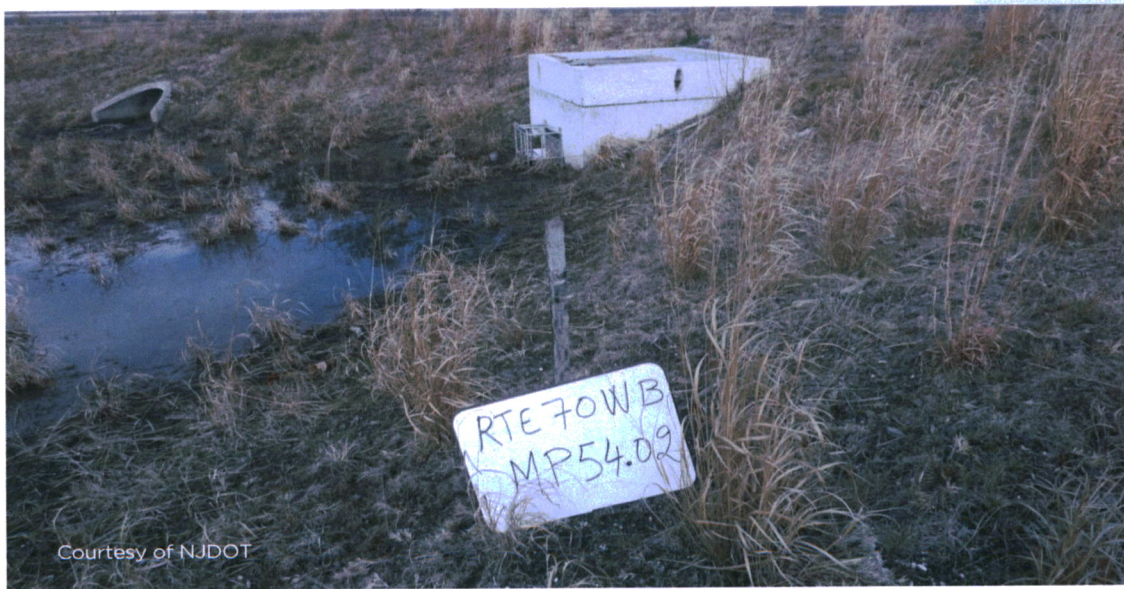
Issue:

The vegetation loss and the blackish soil may indicate frequent inundation.

Check the permeability rate of the soil and the water table elevation. Replace the soil if necessary.

Routine inspection and tilling/aeration, if necessary.

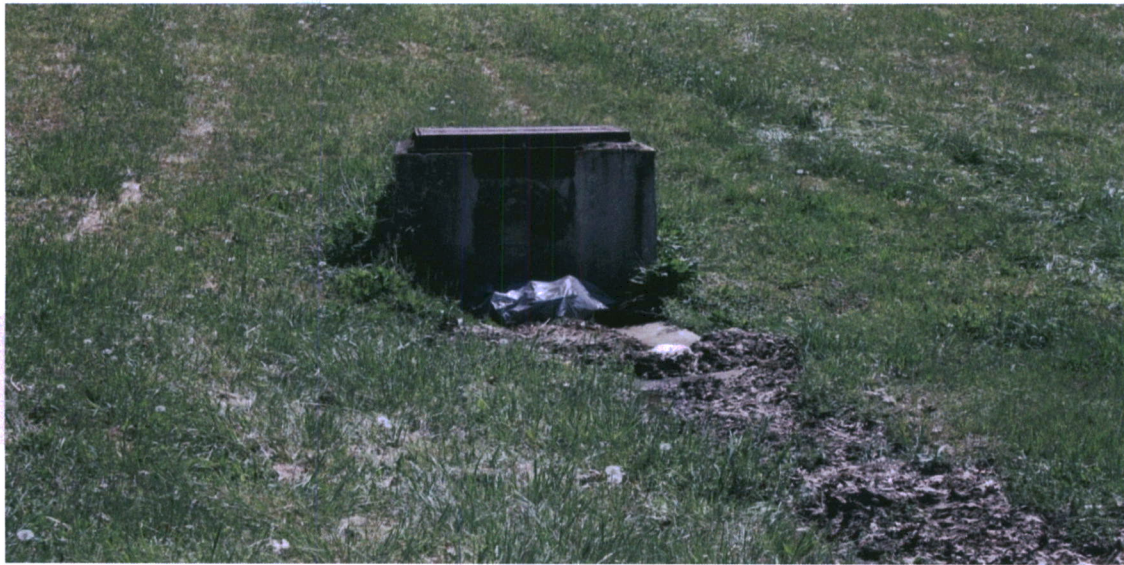
Issue:

The low flow channel has excessive accumulation of sediment and debris. The outflow orifice is clogged by a trash bag and debris. Note that there is no trash rack installed.

Check the permeability rate of the soil and the water table elevation. Replace the soil if necessary.

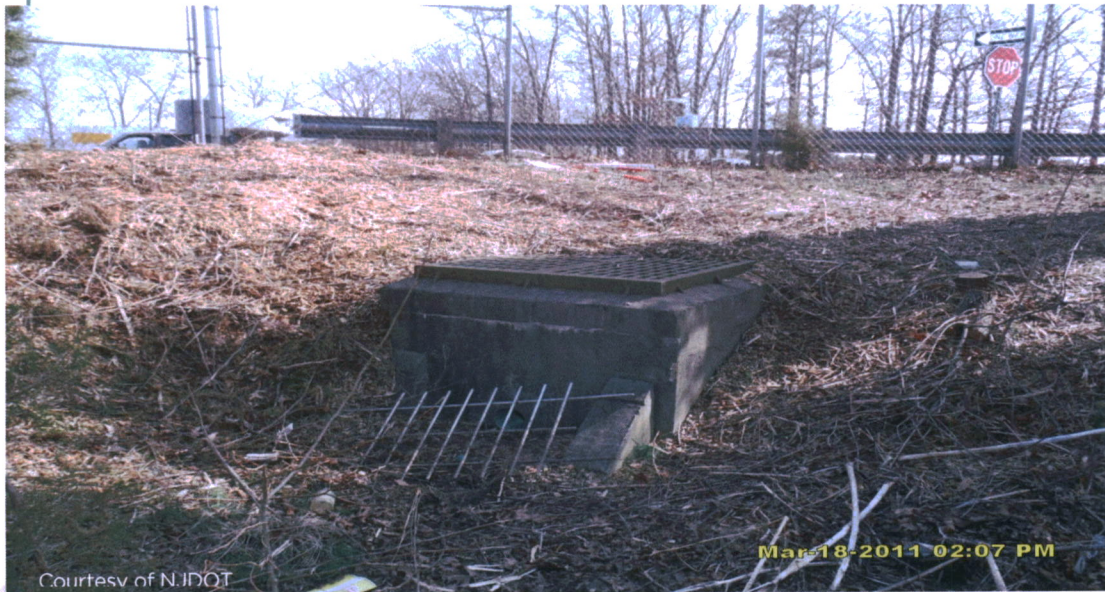
Issue:	Trash rack is damaged.
Corrective Action:	Repair the trash rack.
Preventative Action:	Routine inspection, especially after large storm events. Tighten any loose bolts and repair structural flaws.

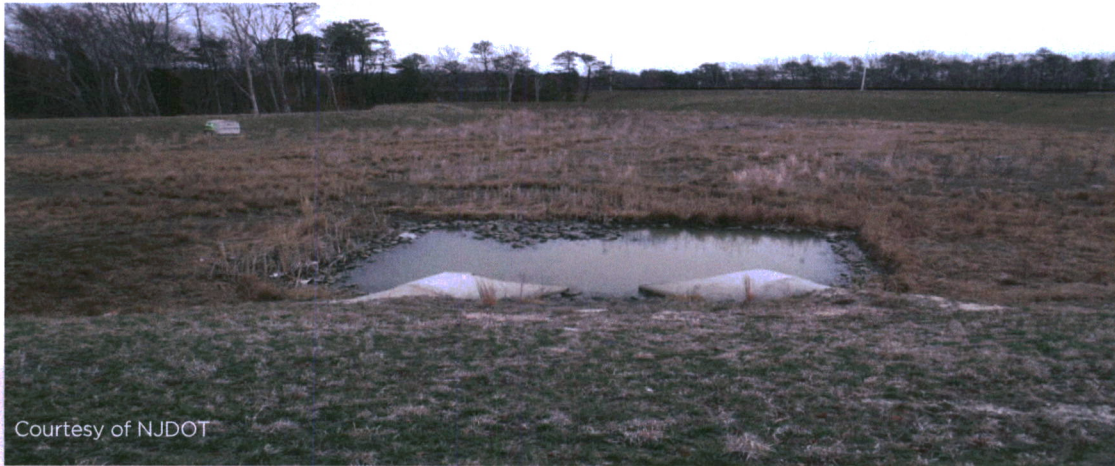
Issue:	The inlet is not properly drained, assuming it has not rained within 72 hours.
Corrective Action:	Clear and remove sediment. Check whether the water table is at or above the bottom of the forebay. Also check the permeability of the underlying soil, if necessary.
Preventative Action:	Routine inspections and removal of sediment from the forebay.

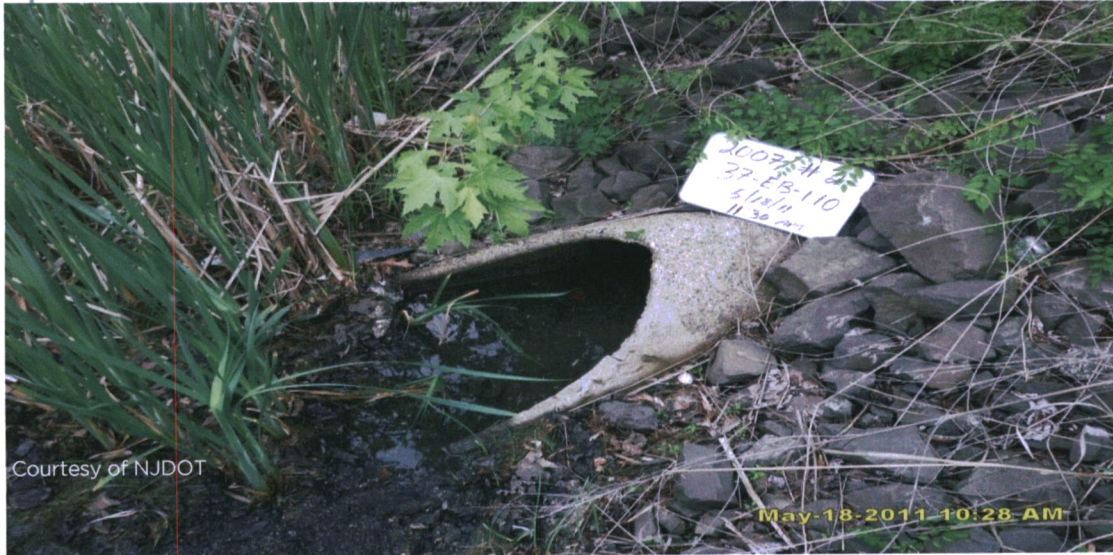
Issue: The Inflow pipe is clogged by sediment and vegetation.

Corrective Action: Clear and remove sediment and unwanted vegetation.

Preventative Action: Routine inspection and removal of sediment and unwanted vegetation.

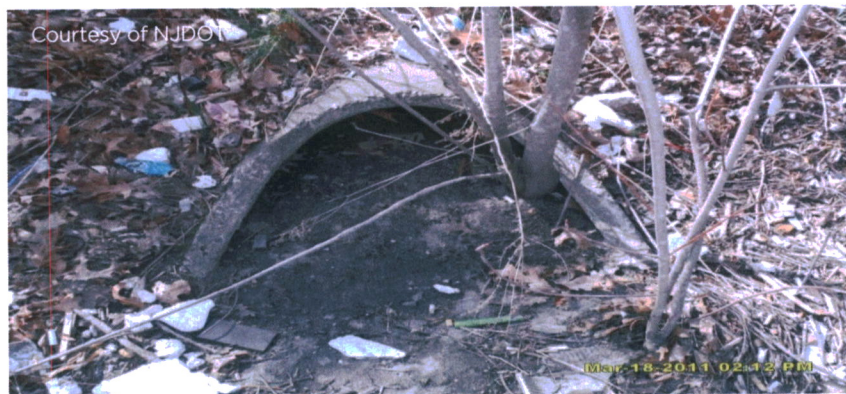
Issue: The Inflow pipe is entirely clogged by sediment and trees.

Corrective Action: Clear and remove sediment and trees.

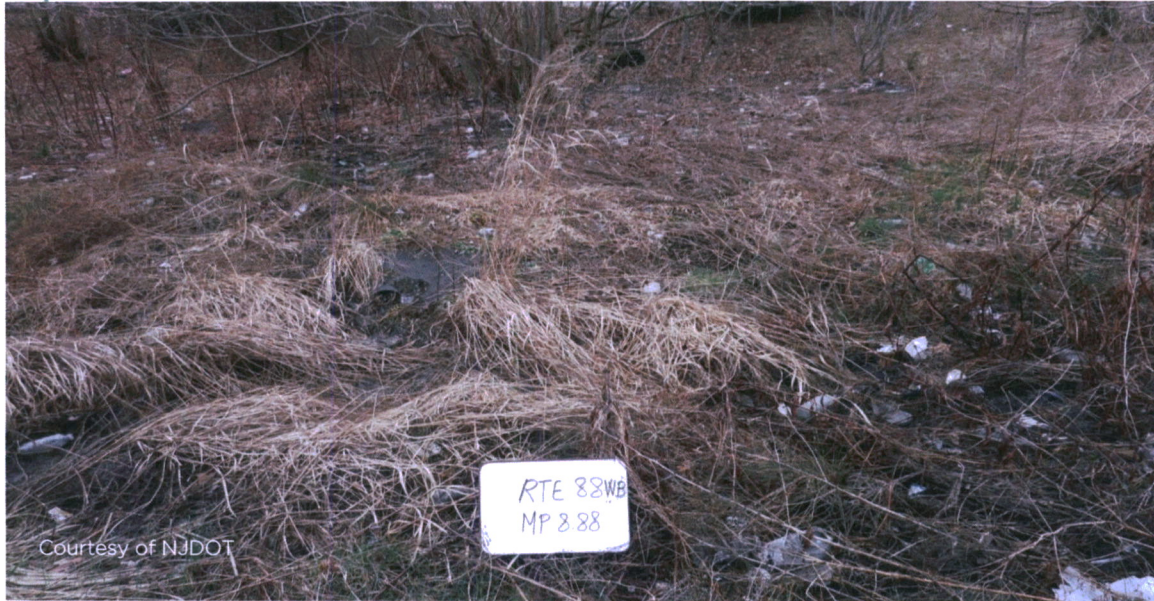
Issue:

The excessive sediment in inflow pipe (shown above) might be caused by a blockage of flow to the basin due to excessive vegetation and overgrown trees.

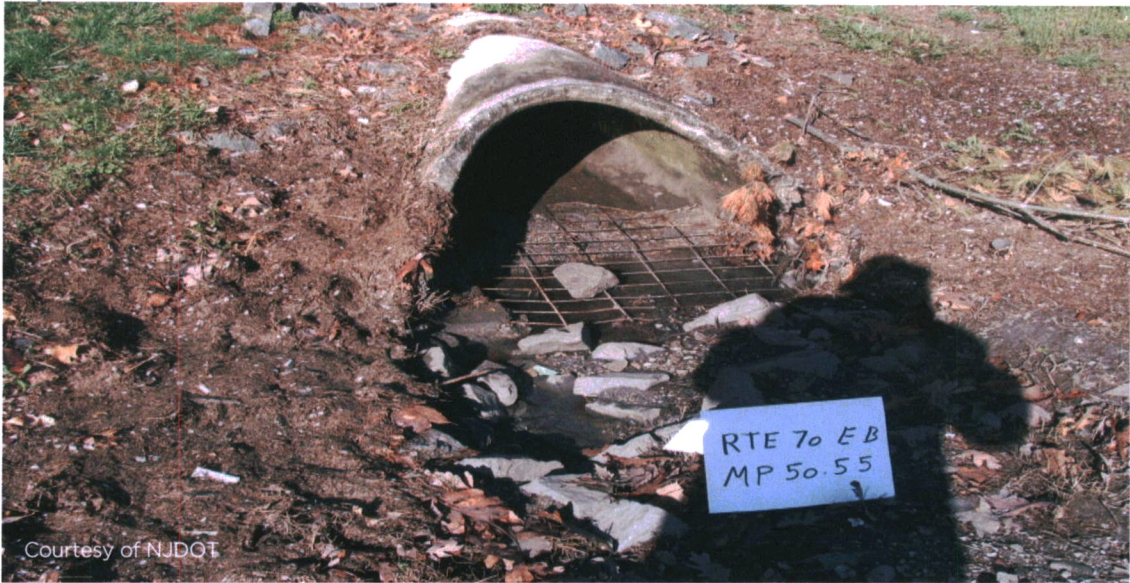
Issue:	Eroded inflow apron.
Corrective Action:	Repair apron.
Preventative Action:	Routine inspection and rehabilitation, if necessary.

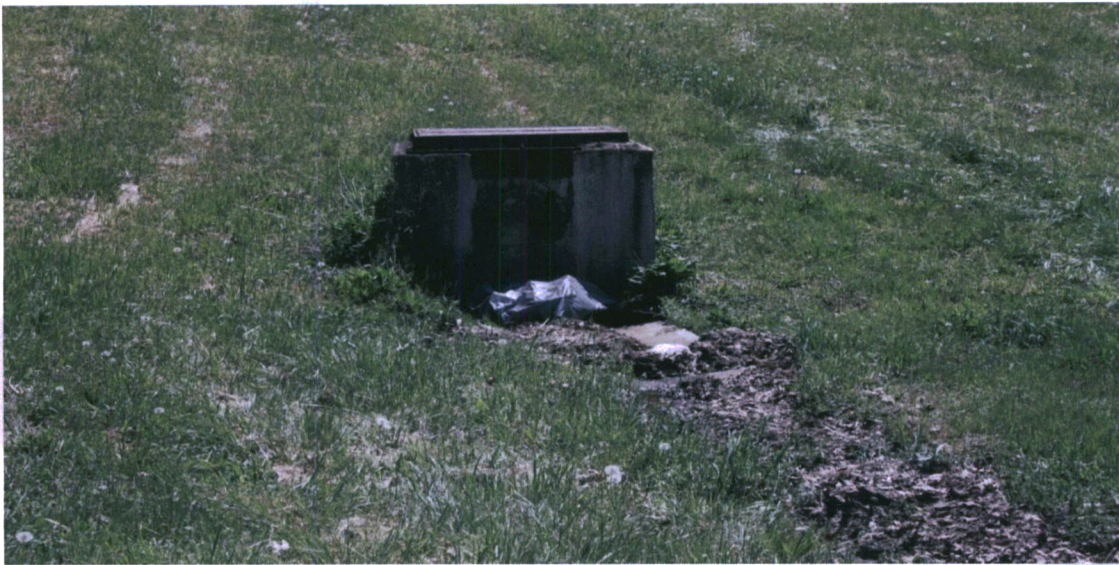
Issue:

The low flow channel has excessive accumulation of sediment and debris. The outflow orifice is clogged by a trash bag and debris. Note that there is no trash rack installed.

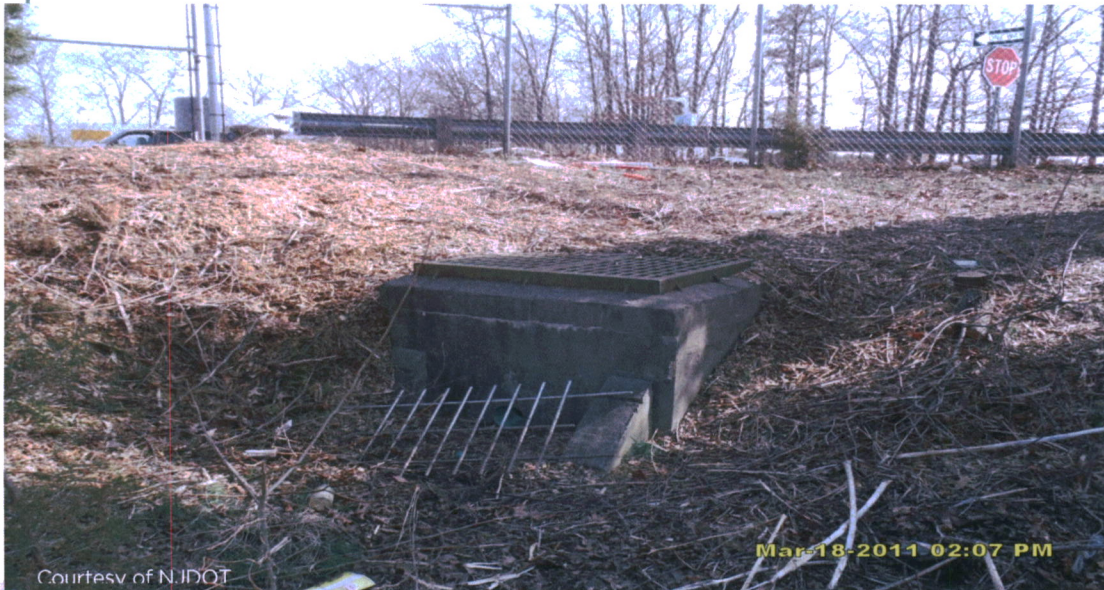
Issue: Trash rack is damaged.

Corrective Action: Repair the trash rack.

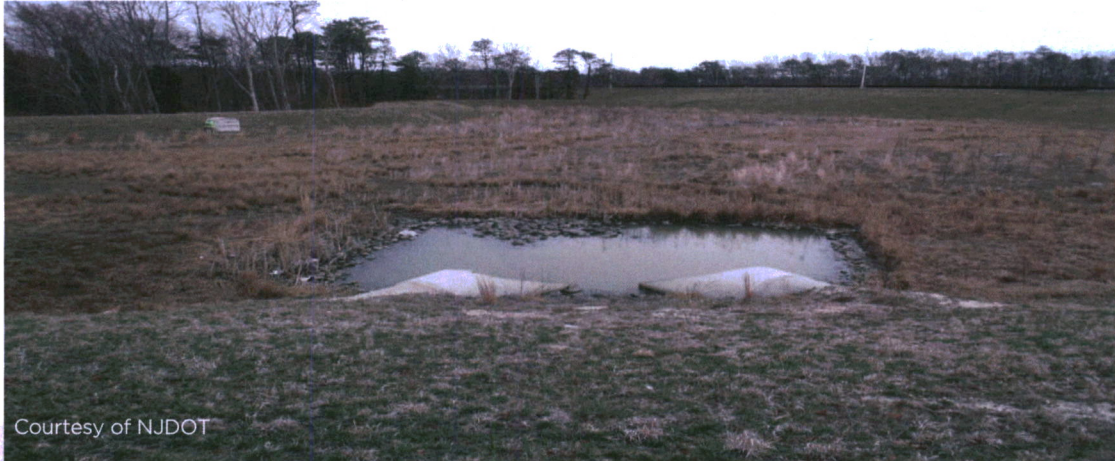
Issue:	The inlet is not properly drained, assuming it has not rained within 72 hours.
Corrective Action:	Clear and remove sediment. Check whether the water table is at or above the bottom of the forebay. Also check the permeability of the underlying soil, if necessary.
Preventative Action:	Routine inspections and removal of sediment from the forebay.

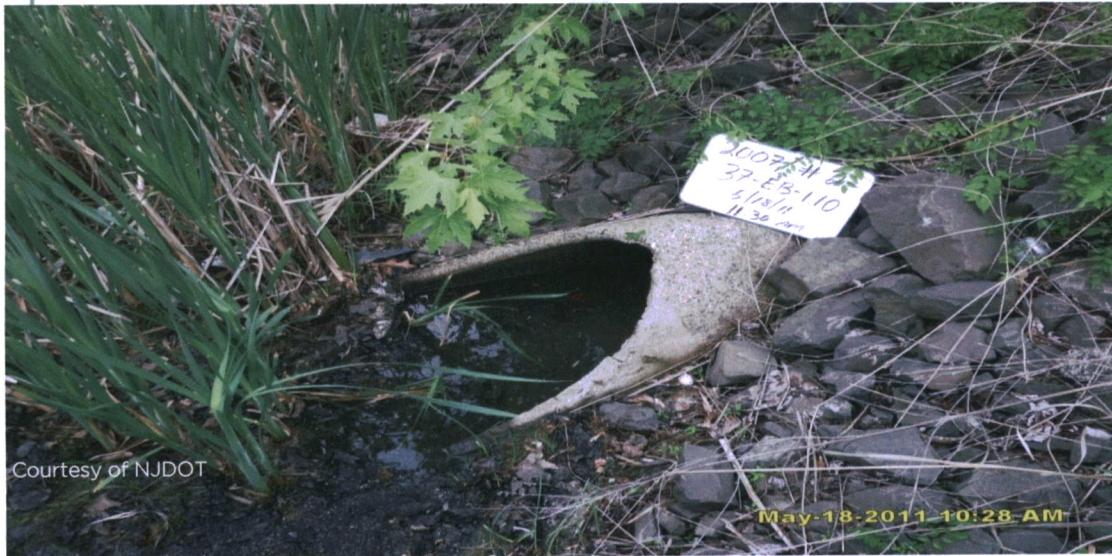
Issue: The Inflow pipe is clogged by sediment and vegetation.

Corrective Action: Clear and remove sediment and unwanted vegetation.

Preventative Action: Routine inspection and removal of sediment and unwanted vegetation.

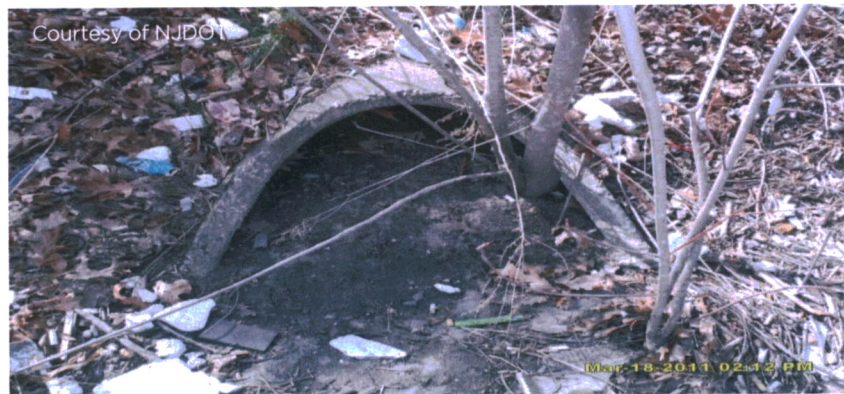
Issue: The Inflow pipe is entirely clogged by sediment and trees.

Corrective Action: Clear and remove sediment and trees.

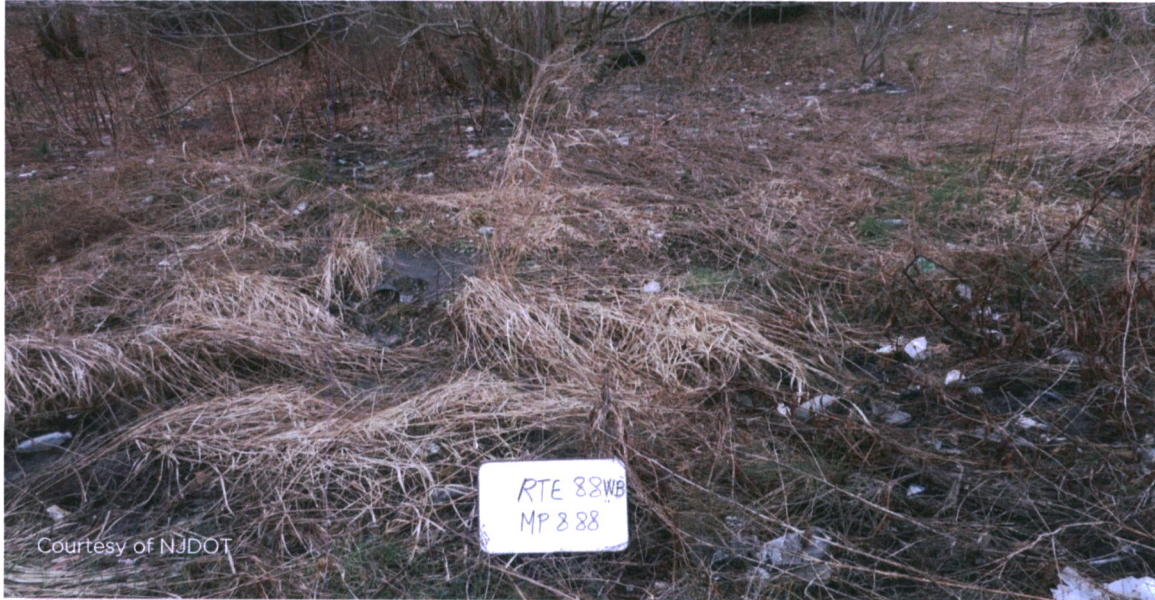
Issue:

The excessive sediment in inflow pipe (shown above) might be caused by a blockage of flow to the basin due to excessive vegetation and overgrown trees.

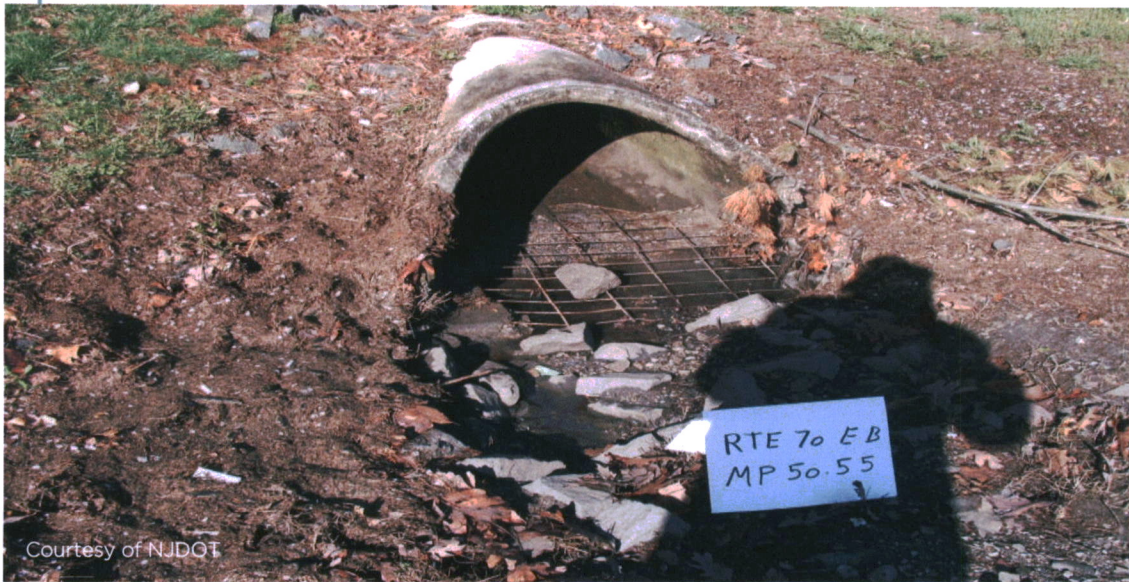
Issue:	Eroded inflow apron.
Corrective Action:	Repair apron.
Preventative Action:	Routine inspection and rehabilitation, if necessary.

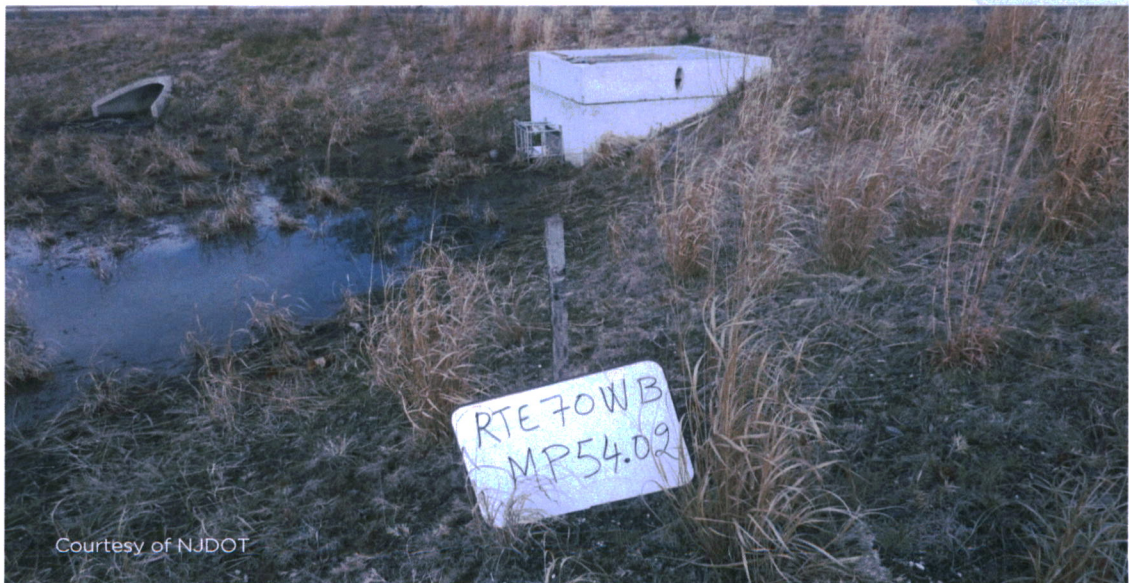
Issue:

The vegetation loss and the blackish soil may indicate frequent inundation.

Routine inspection and tilling/aeration, if necessary.

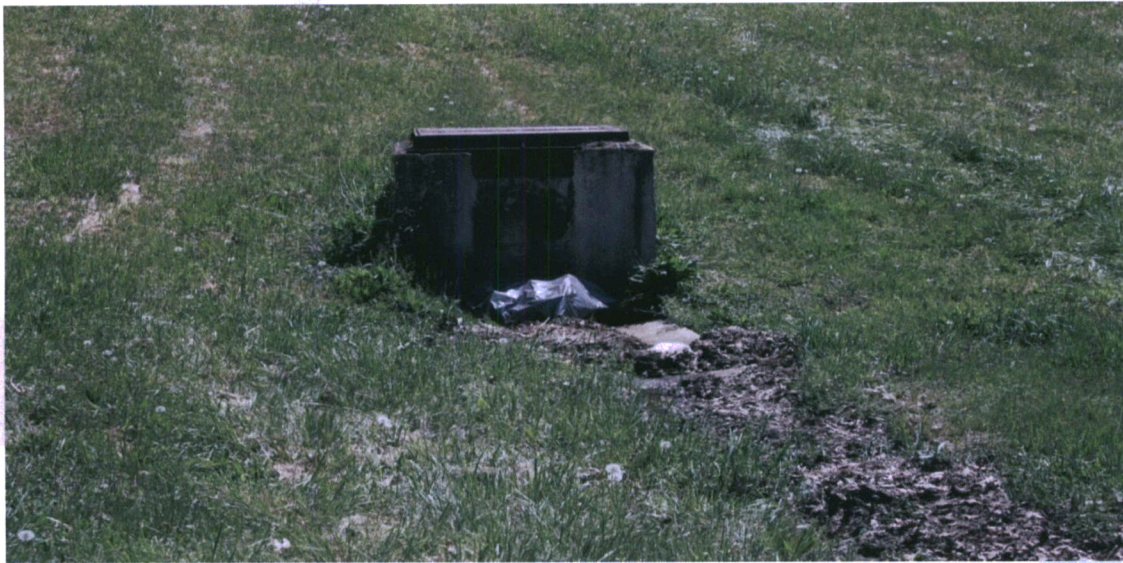
Issue:

The low flow channel has excessive accumulation of sediment and debris. The outflow orifice is clogged by a trash bag and debris. Note that there is no trash rack installed.

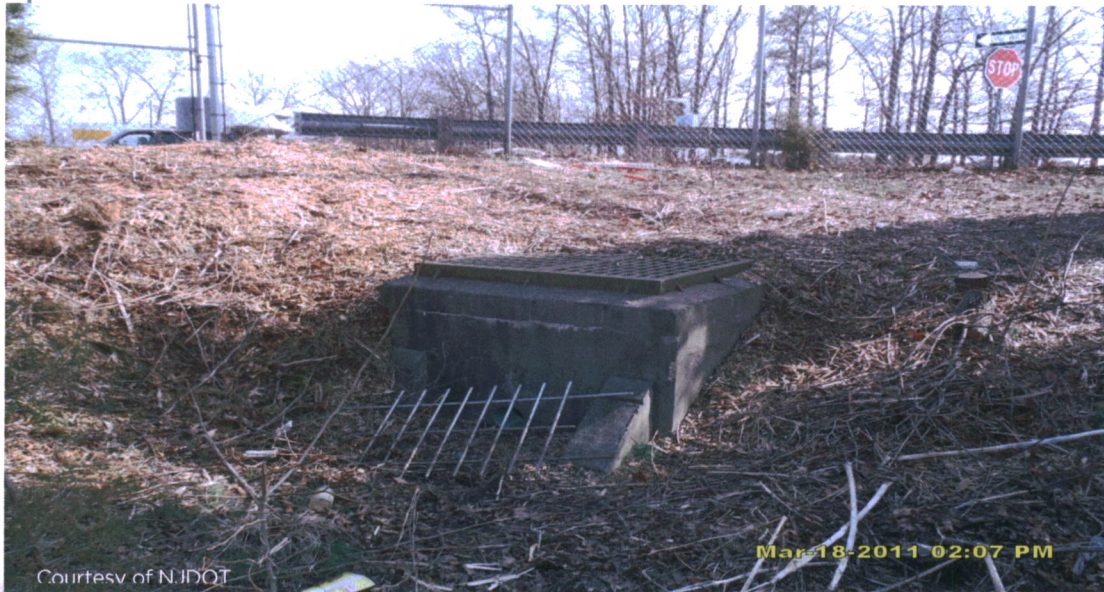
Issue:	Trash rack is damaged.
Corrective Action:	Repair the trash rack.
Preventative Action:	Routine inspection, especially after large storm events. Tighten any loose bolts and repair structural flaws.

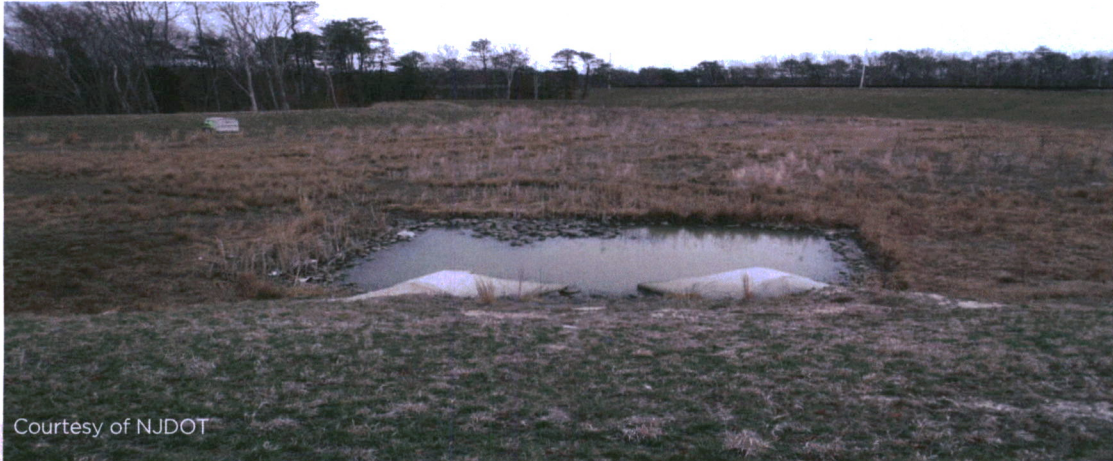
Issue:	The inlet is not properly drained, assuming it has not rained within 72 hours.
Corrective Action:	Clear and remove sediment. Check whether the water table is at or above the bottom of the forebay. Also check the permeability of the underlying soil, if necessary.
Preventative Action:	Routine inspections and removal of sediment from the forebay.

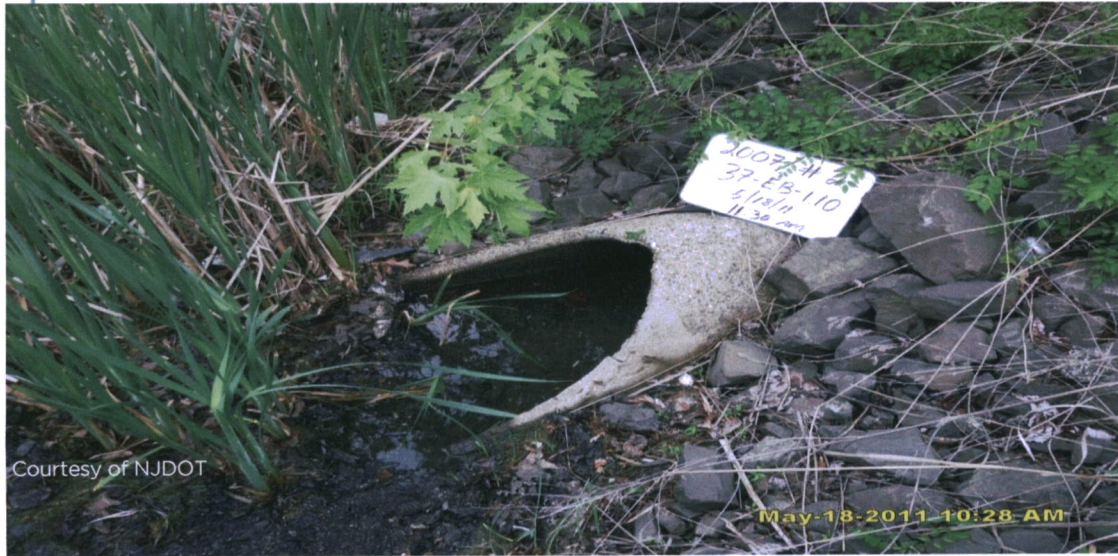
Issue: The Inflow pipe is clogged by sediment and vegetation.

Corrective Action: Clear and remove sediment and unwanted vegetation.

Preventative Action: Routine inspection and removal of sediment and unwanted vegetation.

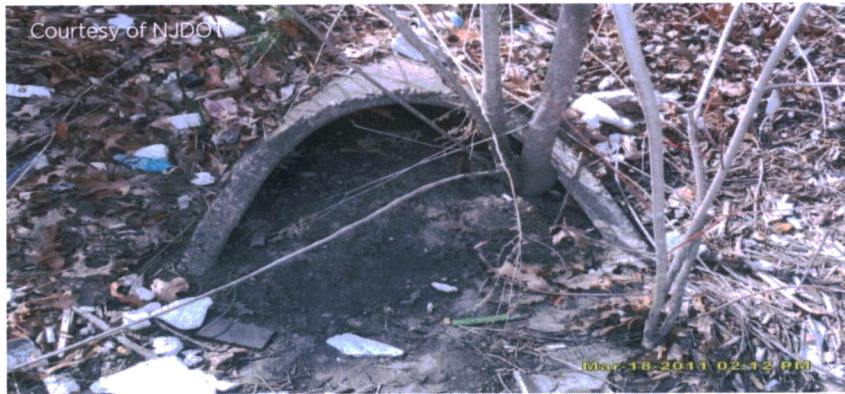
Issue: The Inflow pipe is entirely clogged by sediment and trees.

Corrective Action: Clear and remove sediment and trees.

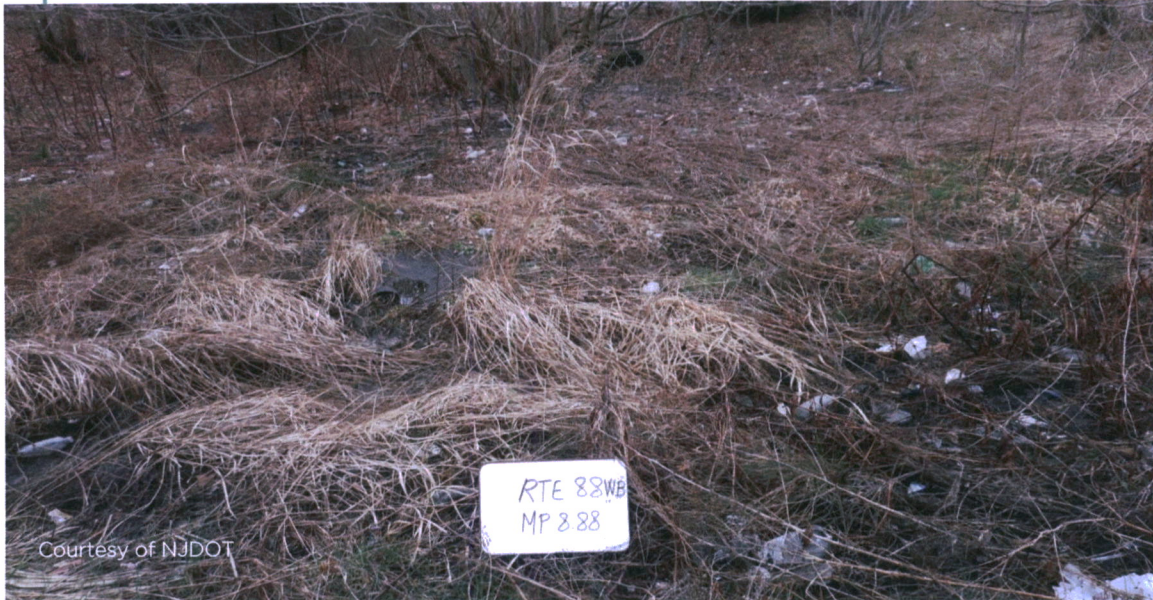
Issue:	The excessive sediment in inflow pipe (shown above) might be caused by a blockage of flow to the basin due to excessive vegetation and overgrown trees.
Corrective Action:	Clear and remove trees and vegetation. If necessary, re-grade the bottom slope to ensure the flow properly spreads over the basin bottom.
Preventative Action:	Routine inspection and removal of sediment and unwanted vegetation.
