STORMWATER
MANAGEMENT
MAINTENANCE
MANUAL

248 Stickles Pond Road
Block 151 Lot 21
Andover Township
Sussex County, New
Jersey

Prepared For:
BHT Properties Group
5081 SW 48th Street, 1023
Davie, Florida 33314

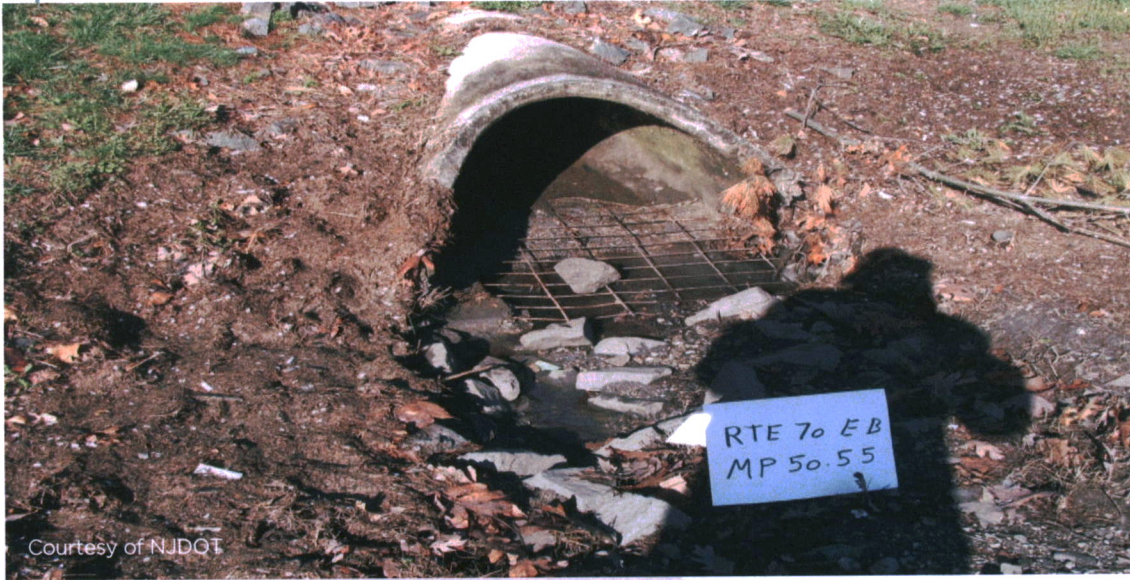
Issue: Eroded inflow apron.
Corrective Action: Repair apron.
Preventative Action: Routine inspection and rehabilitation, if necessary.

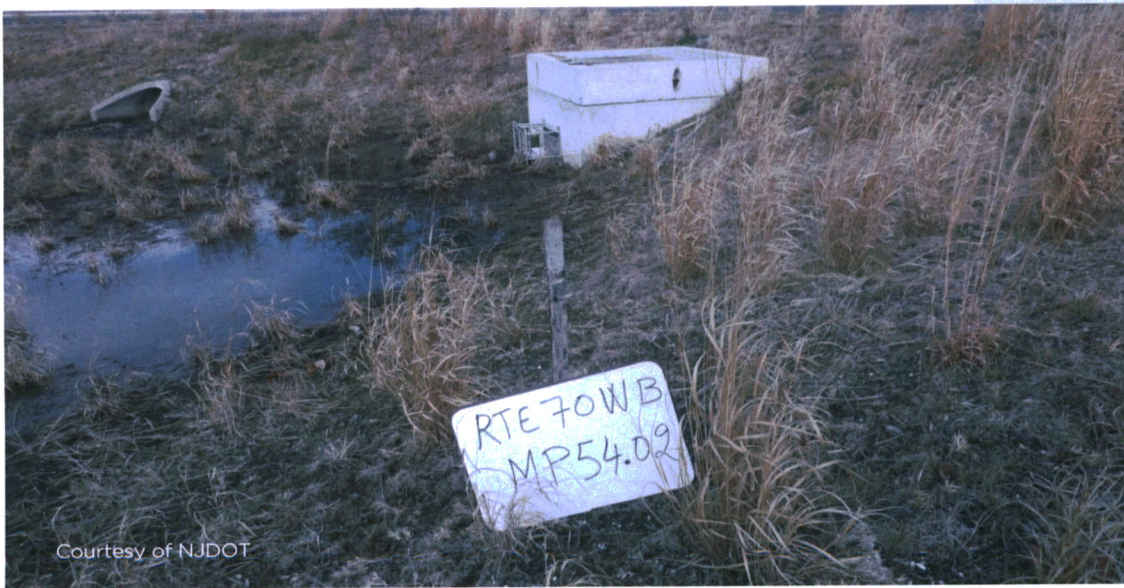
Issue:

The vegetation loss and the blackish soil may indicate frequent inundation.

Routine inspection and tilling/aeration, if necessary.

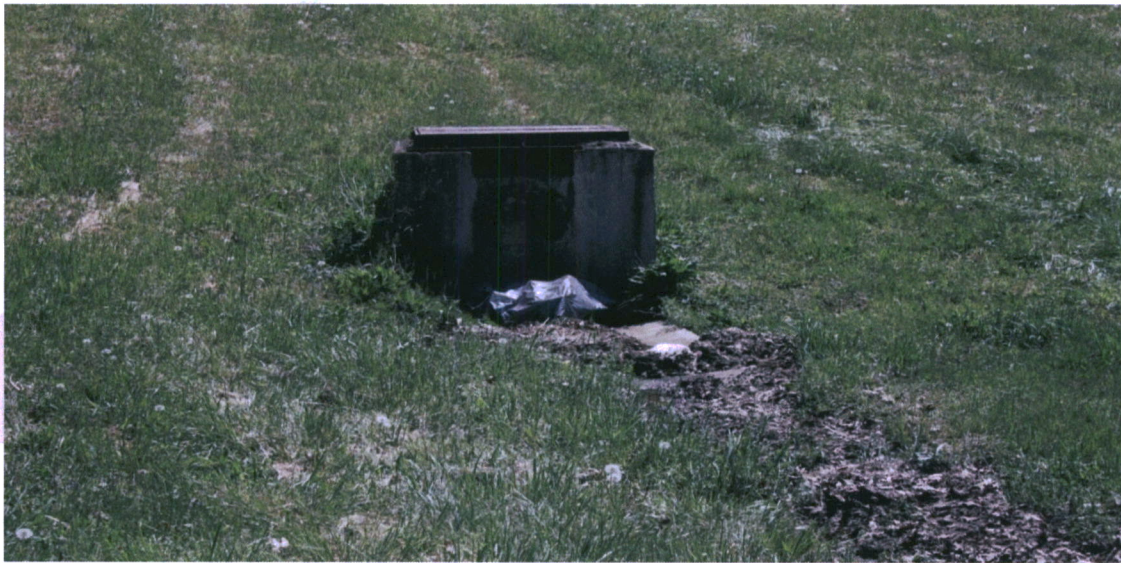
Issue:

The low flow channel has excessive accumulation of sediment and debris. The outflow orifice is clogged by a trash bag and debris. Note that there is no trash rack installed.

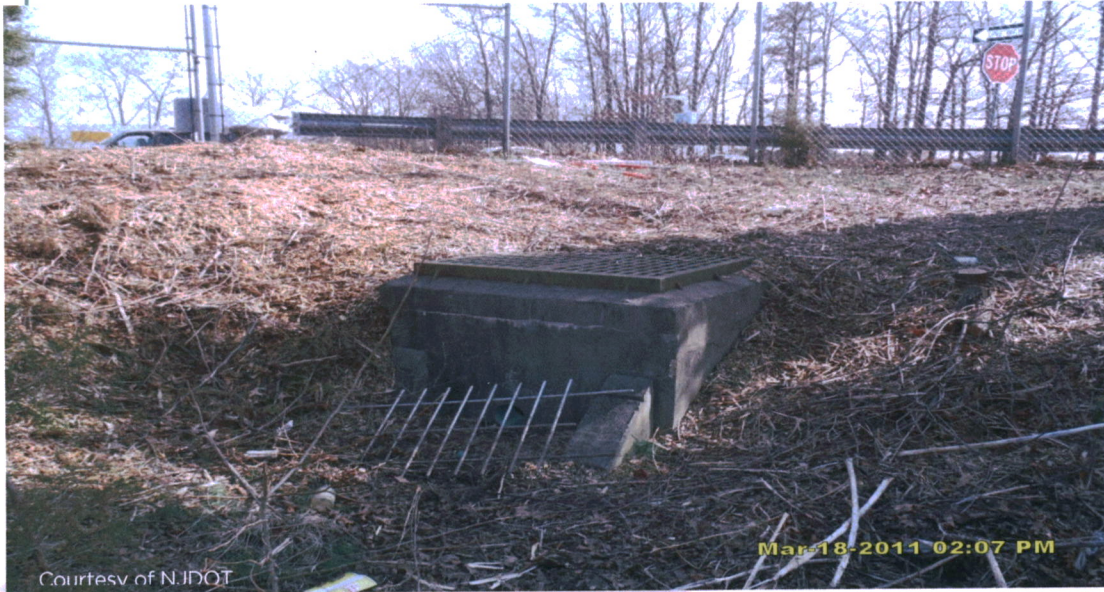
Issue: Trash rack is damaged.

Corrective Action: Repair the trash rack.

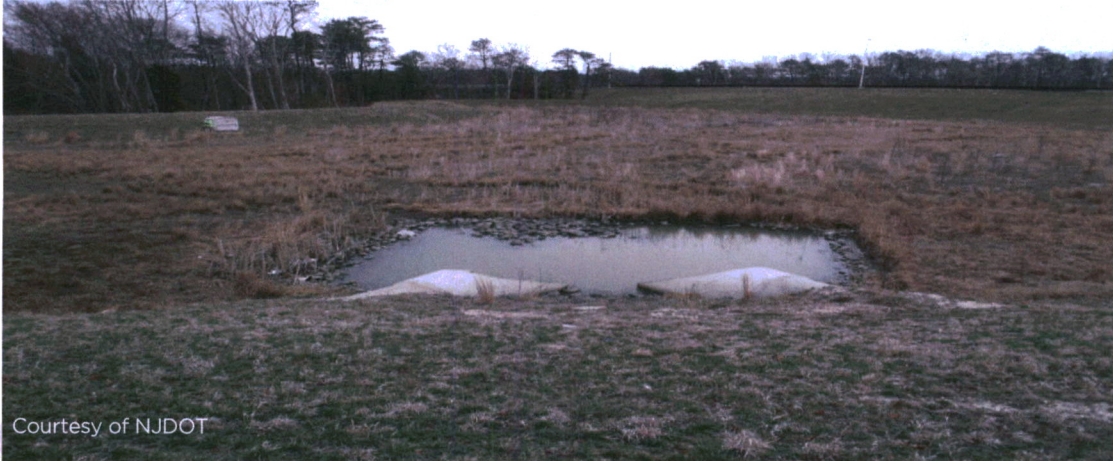
Issue:	The inlet is not properly drained, assuming it has not rained within 72 hours.
Corrective Action:	Clear and remove sediment. Check whether the water table is at or above the bottom of the forebay. Also check the permeability of the underlying soil, if necessary.
Preventative Action:	Routine inspections and removal of sediment from the forebay.

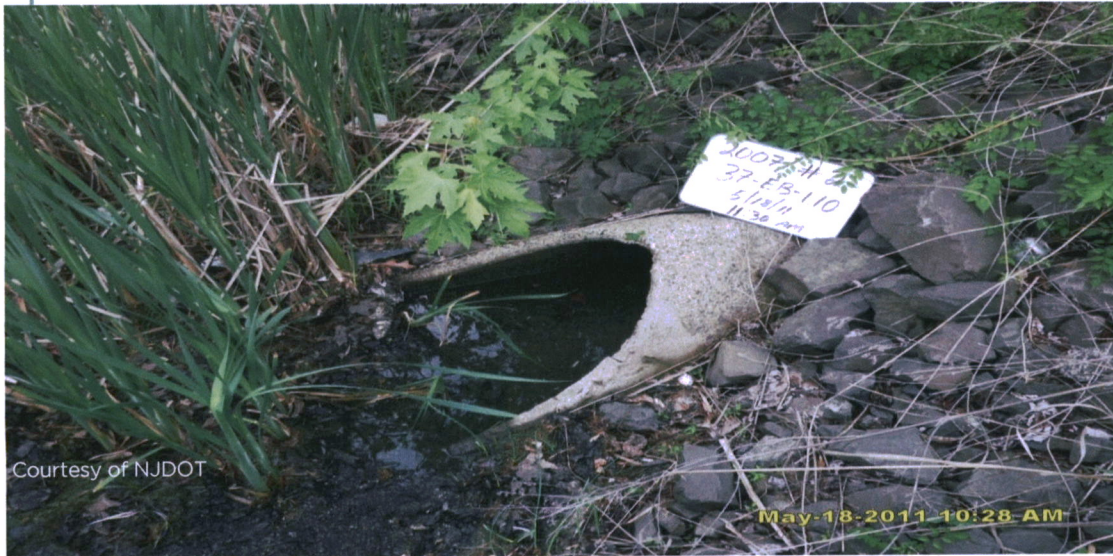
- Issue: The Inflow pipe is clogged by sediment and vegetation.
- Corrective Action: Clear and remove sediment and unwanted vegetation.
- Preventative Action: Routine inspection and removal of sediment and unwanted vegetation.

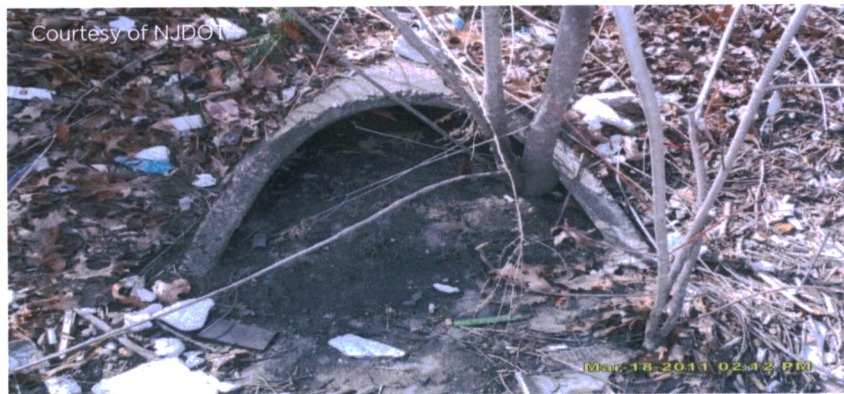
- Issue: The Inflow pipe is entirely clogged by sediment and trees.
- Corrective Action: Clear and remove sediment and trees.
- Preventative Action: Routine inspection & removal of sediment and unwanted vegetation.

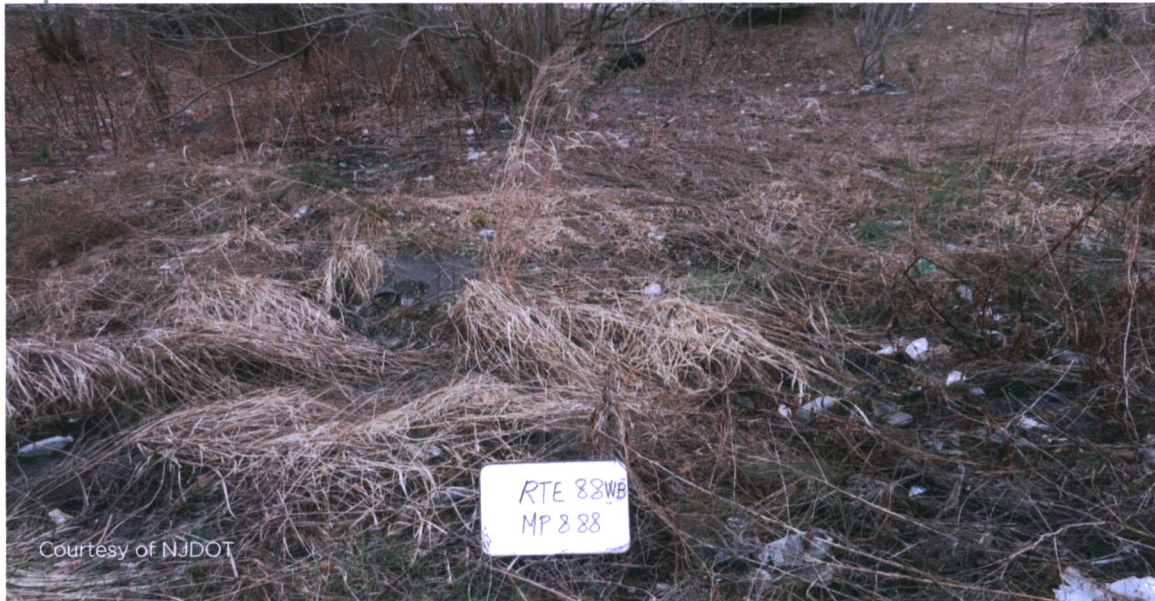
Issue:

The excessive sediment in inflow pipe (shown above) might be caused by a blockage of flow to the basin due to excessive vegetation and overgrown trees.

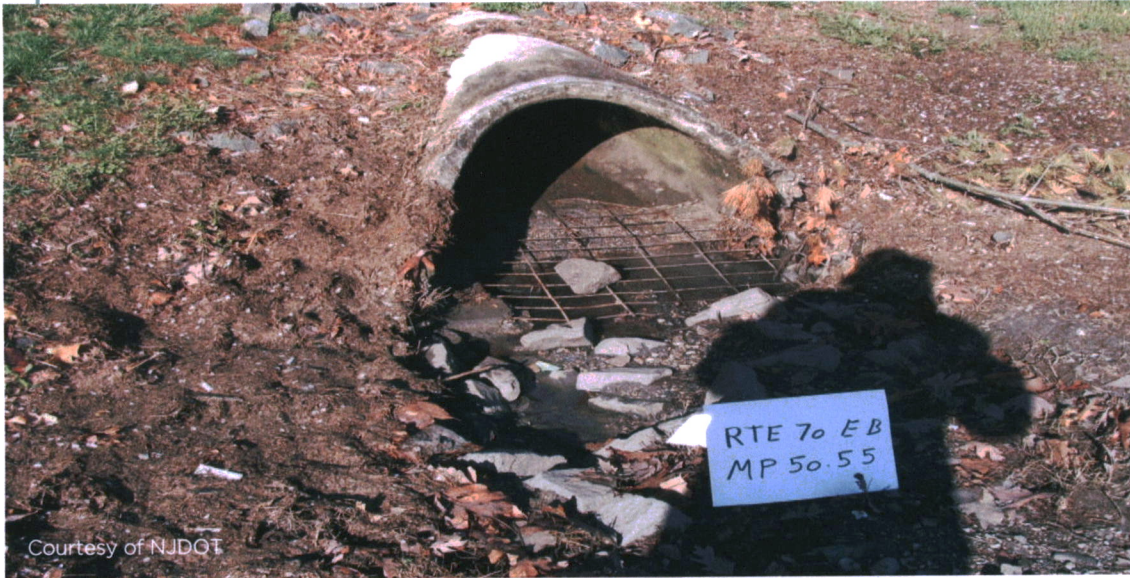
Issue:	Eroded inflow apron.
Corrective Action:	Repair apron.
Preventative Action:	Routine inspection and rehabilitation, if necessary.

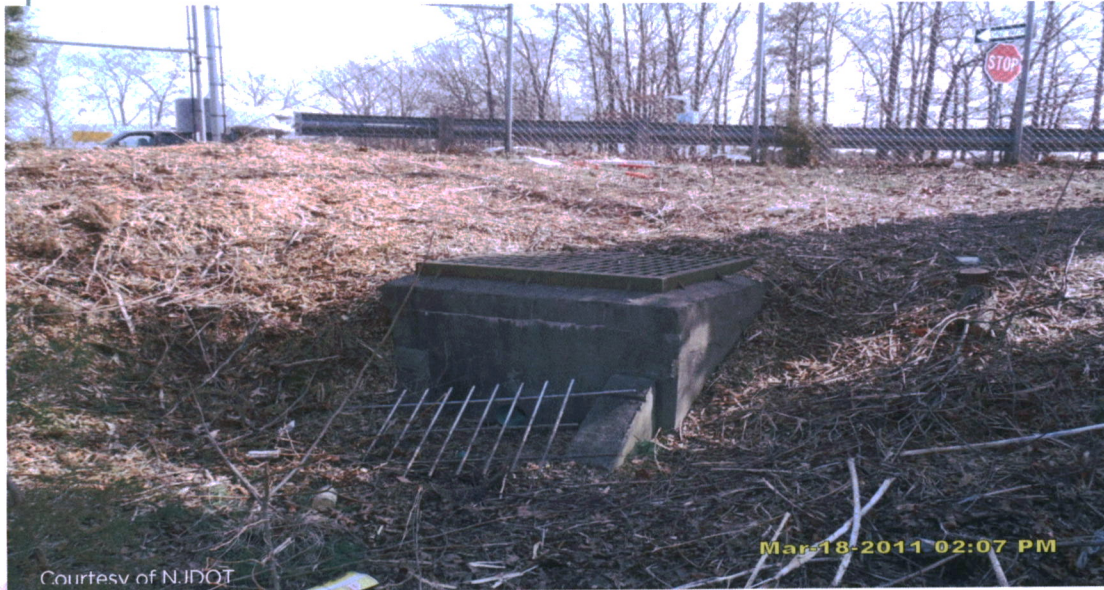
Issue:	Trash rack is damaged.
Corrective Action:	Repair the trash rack.
Preventative Action:	Routine inspection, especially after large storm events. Tighten any loose bolts and repair structural flaws.
